# Analyses of Landscape Design and Maintenance Requirements in Urban Parking Lots<sup>1</sup>

Christina A. Pfeiffer, John A. Wott, and James R. Clark<sup>2</sup>

Center for Urban Horticulture, GF-15

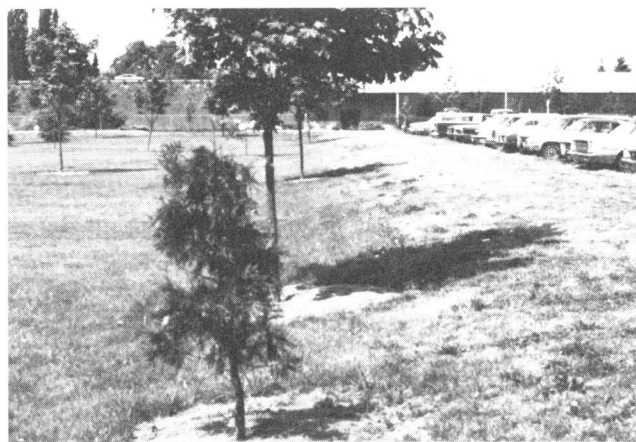
Fig. 2. Soil compaction along a parking lot perimeter. The boundary where grading ended is evident along the light-colored strip adjacent to the parked cars. Eighteen *Thuja plicata* were planted in this strip four years earlier.

Adherence to soil specifications was also variable. Where there should have been a uniform condition, layers of clay were interspersed in the parking island topsoil.

Soil conditions at construction sites have been identified as a major limitation to plant establishment (1, 14, 22, 29, 30, 31). The construction procedures for these parking lots were very destructive to soil structure. Specifications required the subgrade for pavement to be compacted to 95% standard density (37). This translates to a total pore space of 5% and where grading overlapped into planting areas, it had serious consequences for plant establishment. In a perimeter bed at one site, all 18 *Thuja plicata* Donn, Western red-cedar, had died (Fig. 2). Ideally, soils for planting beds should have a pore space of 45 to 50%, with a bulk density of no greater than 1.3 to 1.4 gr/cm (81 to 87 lbs/ft) (29, 31). Correction of soil compaction and interface problems, and the replacement of the missing plants after construction is far more costly than proper soil management during the original construction.

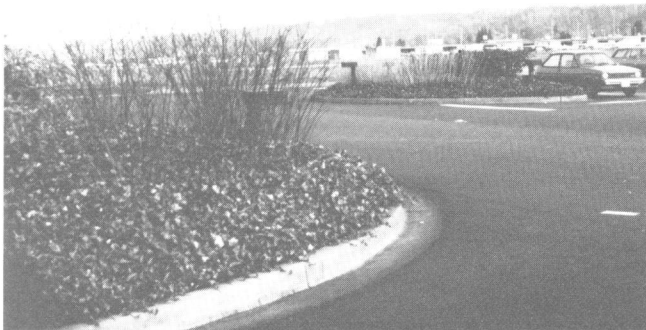
Other species were well-adapted to the site, but were not located appropriately. For example, *Hedera helix* L. 'Baltica,' *Photinia x fraseri* Dress, and either *Cornus alba* 'Sibirica' Loud. or *Cornus sericea* 'Flaviramea' Rehd. were planted together in parking island planters (Fig. 3). *Hedera helix* 'Baltica' requires at least three

Fig. 3. Example of a densely planted parking island bed. The tall heights of *Photinia x fraseri* and *Cornus alba* 'Sibirica' contribute to visibility problems for pedestrians and vehicles. In addition, all the species used require frequent pruning to control their size.

edgings per year in the Pacific northwest, making it a high maintenance choice for island planters and narrow beds. Performance standards for these sites indicated that for safety and visibility, shrubs located within 9 m (30 ft) of an intersection were to be no taller than 0.76 m (2.5 ft) at maturity (27). *Photinia x fraseri* and the two *Cornus* are vigorous plants with rapid growth to over 3.2 m (10 ft) tall and required frequent pruning to maintain the low height. In addition, the *Photinia* were showing trunk dieback from frequent shearing. These shrubs would have been more appropriately used in perimeter beds where their height and spread would be more in scale with the planting space.

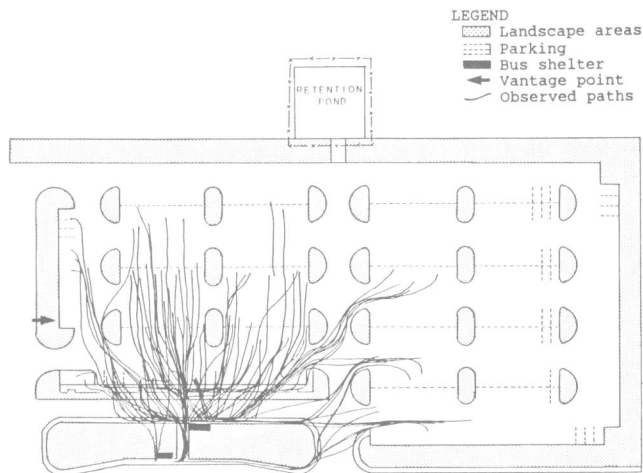
**Human factors.** Pedestrian paths were in radial patterns focusing on the bus shelter area (Fig. 4). Parking spots were filled as a function of nearest distance to the bus stop. People who arrived early tended to follow the paved walkways. However, once a bus arrived, the pace

Fig. 4. Observed pedestrian paths from the parking area to the bus shelter. These paths represent the typical activity of commuters on a normal business day. The pedestrian paths observed for all the lots in this study conformed to a radial pattern as shown for this site.

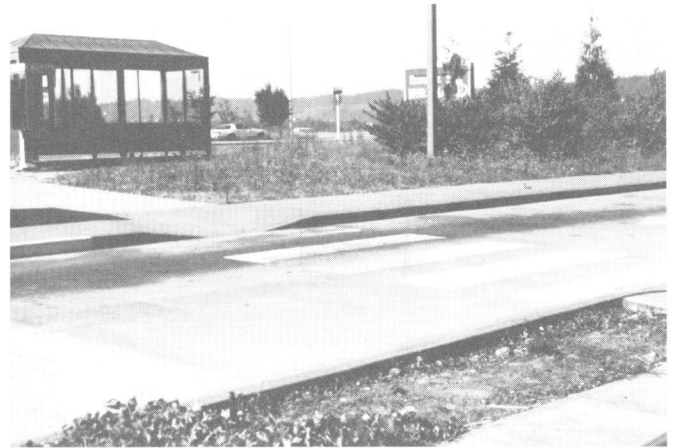
Fig. 5. Physical damage to the planting bed adjacent to the bus shelter directly corresponded to the observed traffic patterns shown in Figure 4. People using the parking lots tended to follow the provided sidewalks until a bus arrived at the stop. Then, they walked directly through any planting beds which intersected direct access to the bus.

quicken to the most direct path, often across a landscape bed. Paths and mechanical damage to planting beds near the bus shelter directly corresponded to the observed pedestrian traffic (Fig. 5). Pedestrian traffic was concentrated near the shelter areas. Designs which provided ample access and walking space around the shelters had less landscape damage and were visually more effective.

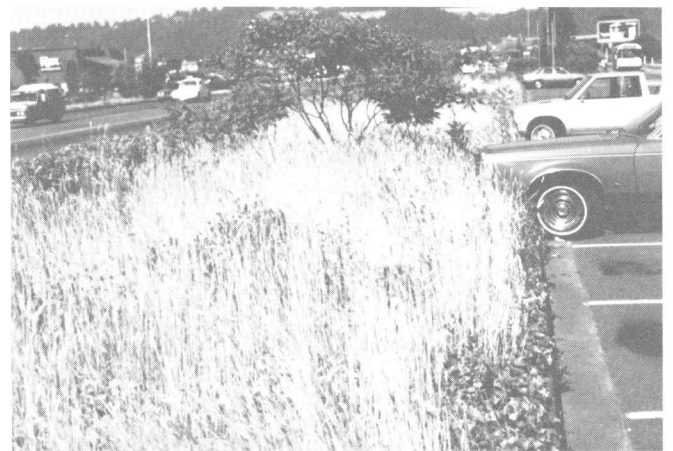
Fig. 6. Dense weed growth in a landscape bed may have contributed to the high mortality of *Rhus glabra* planted there. This problem was likely a combined result of landscape specifications which indicated that herbicides were not to be used, coupled with an inadequate maintenance program after installation.

**Maintenance.** Inadequate maintenance schedules during initial years after installation contributed to many of the plant vigor and mortality problems (Fig. 6). Litter counts indicated that litter clean up would be a required component of the maintenance schedules. Most of the litter items appeared to come from surrounding businesses and fast food chains. Other litter sources resulted
