# Riverbend

## Challenges and Opportunities of Restoring Habitat and Reducing Flood Risk in a Developed, Dynamic Environment

Presented by Michael Thai

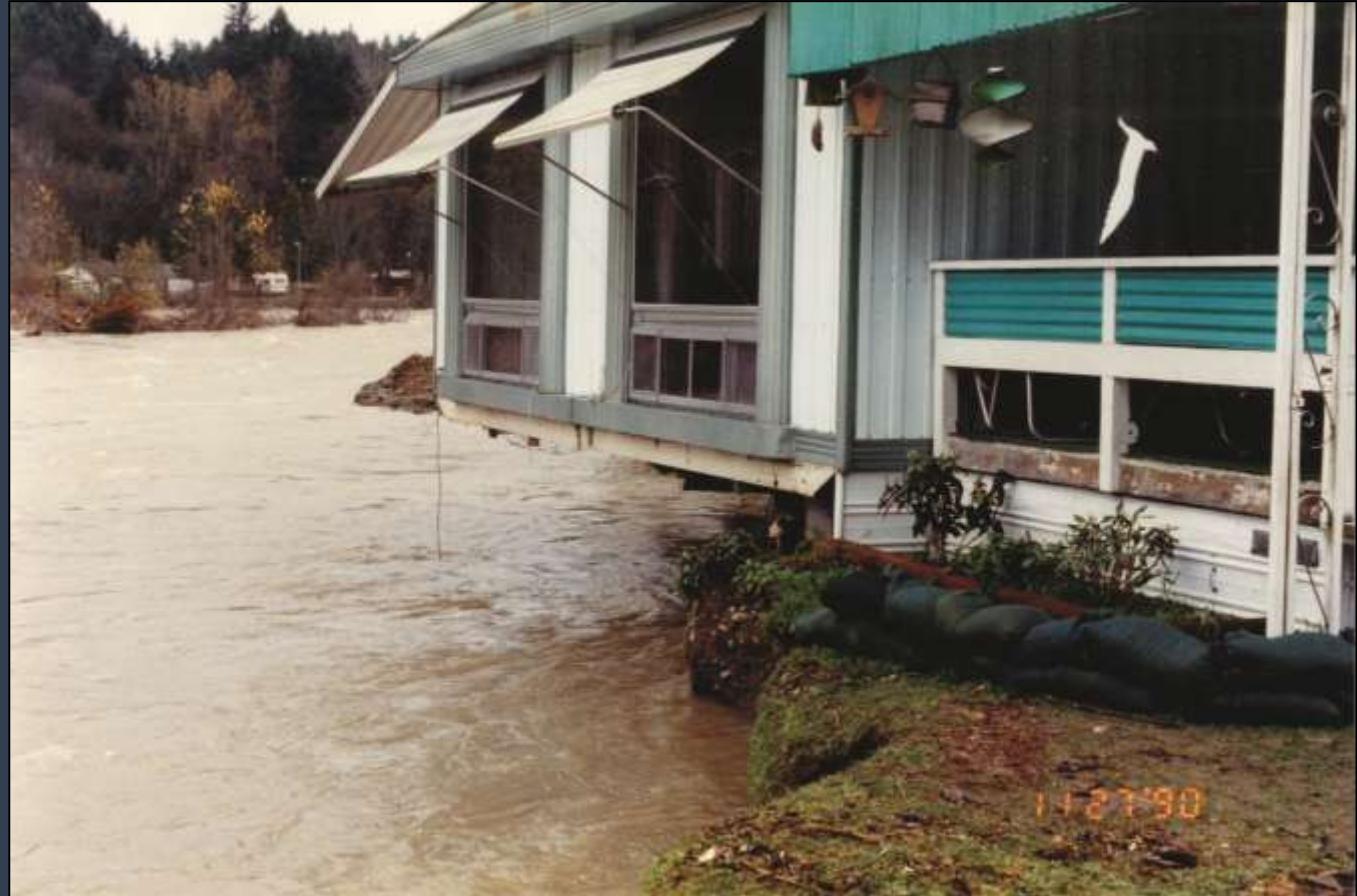
Flood Damage November 1990

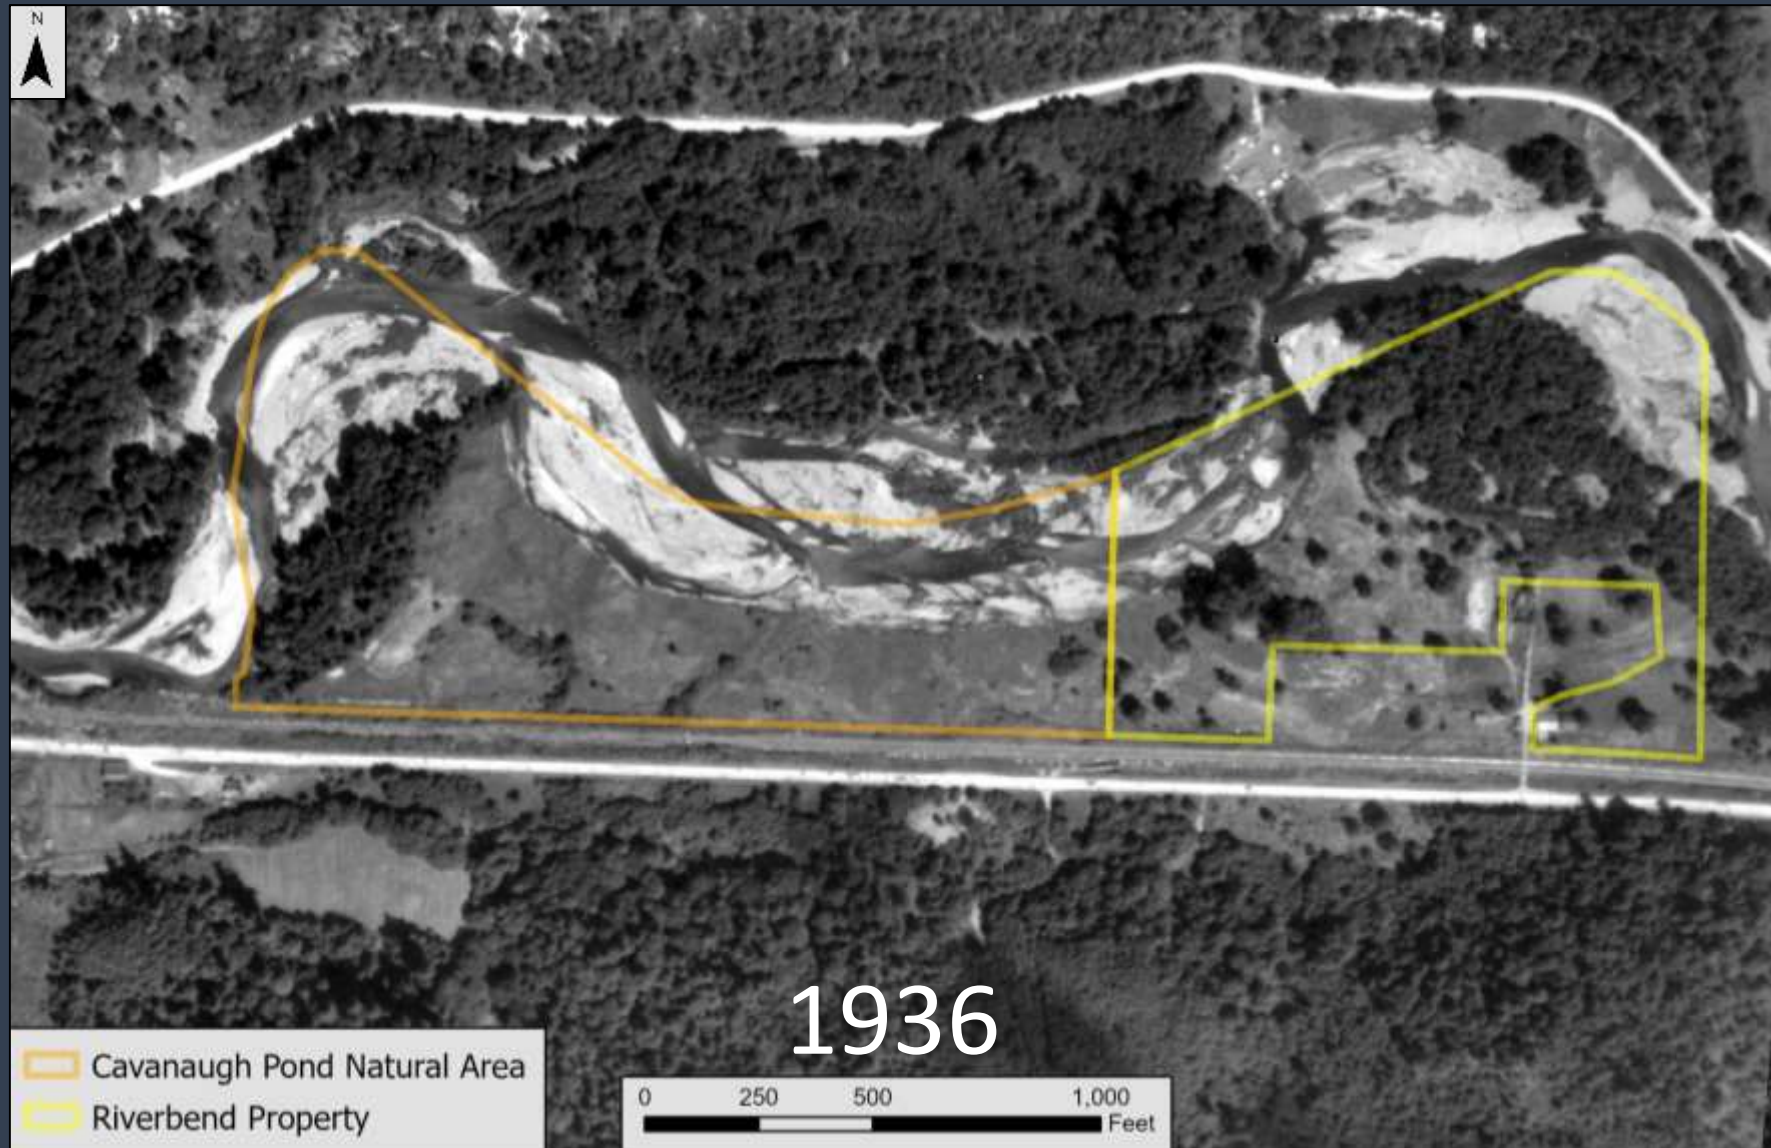
# Levee impairs habitat - Channel simplified and locked in place

- Levee impairs habitat, but doesn't prevent severe flooding
  - Residential areas flood while floodplain stays dry
  - Channel simplified and locked in place
  - Scour intensified in confined reaches
- Repetitive damage to existing levees (\$\$\$)
  - Project team was concerned about an avulsion through Cavanaugh Pond
- Cavanaugh Pond is deep and eutrophying

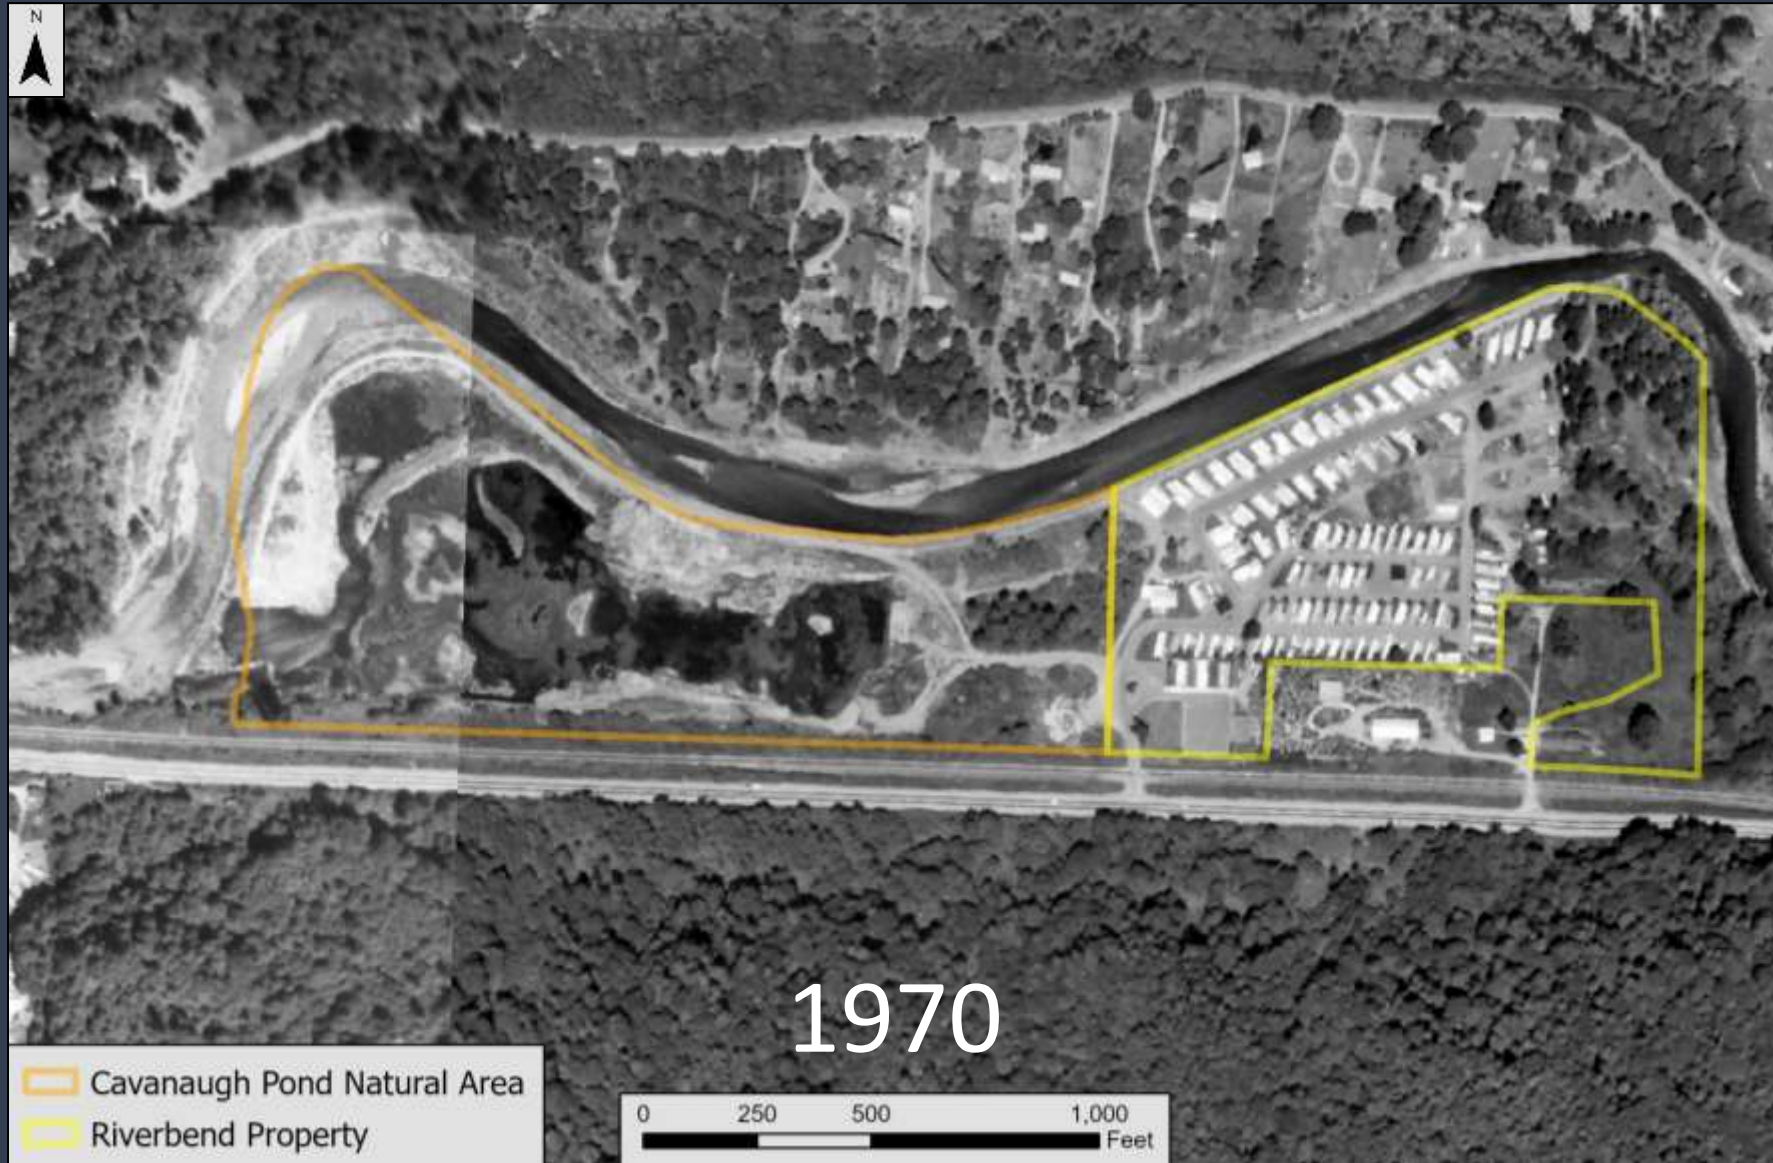
# Levee impairs habitat - Channel simplified and locked in place

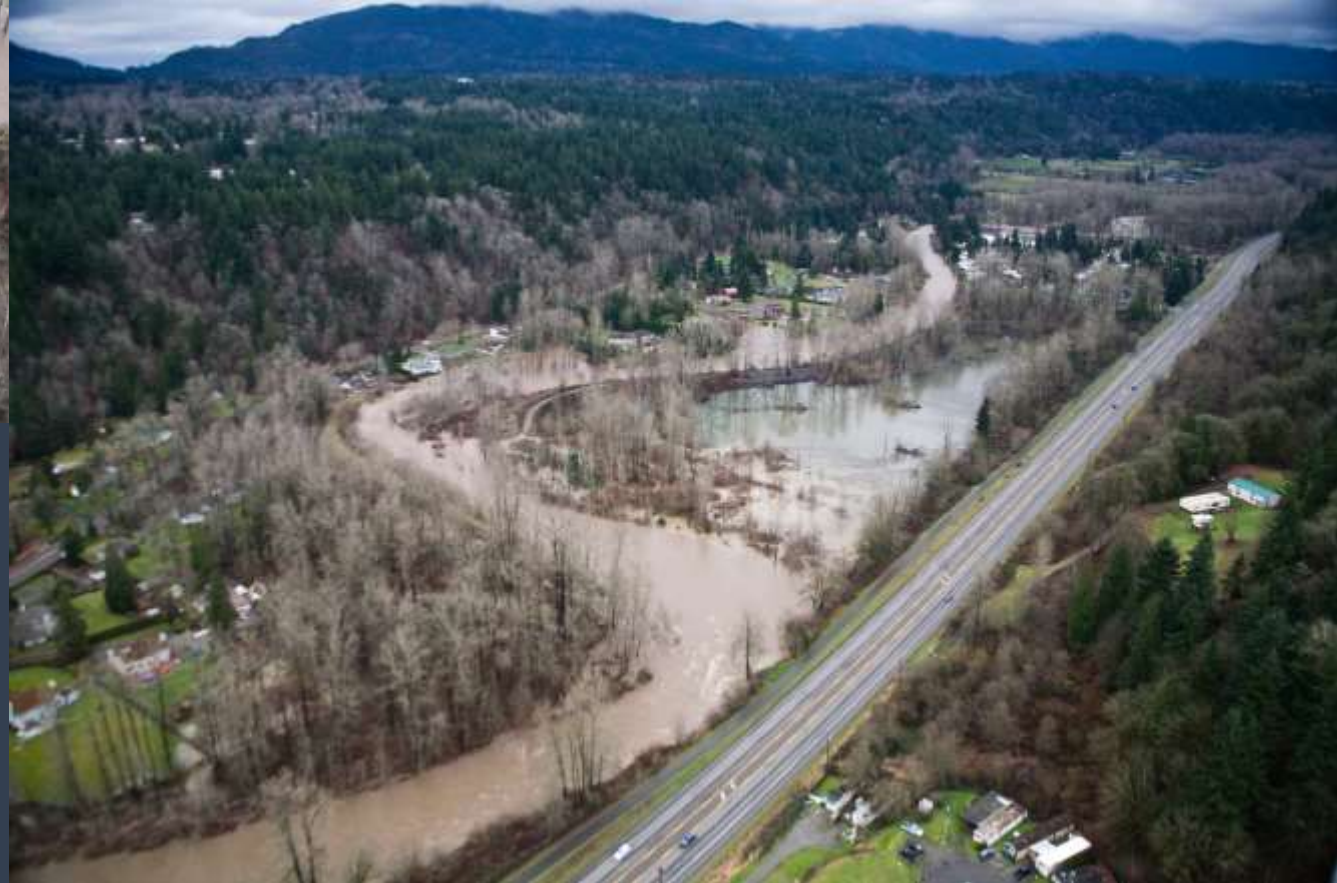
Repetitive damage to existing levees (\$\$\$) – project team was concerned about an avulsion through Cavanaugh Pond

Levees impaired habitat and  
made flooding worse

Flooding (~20-year flood)  
January 8, 2009  
7,870 cfs @ Landsburg

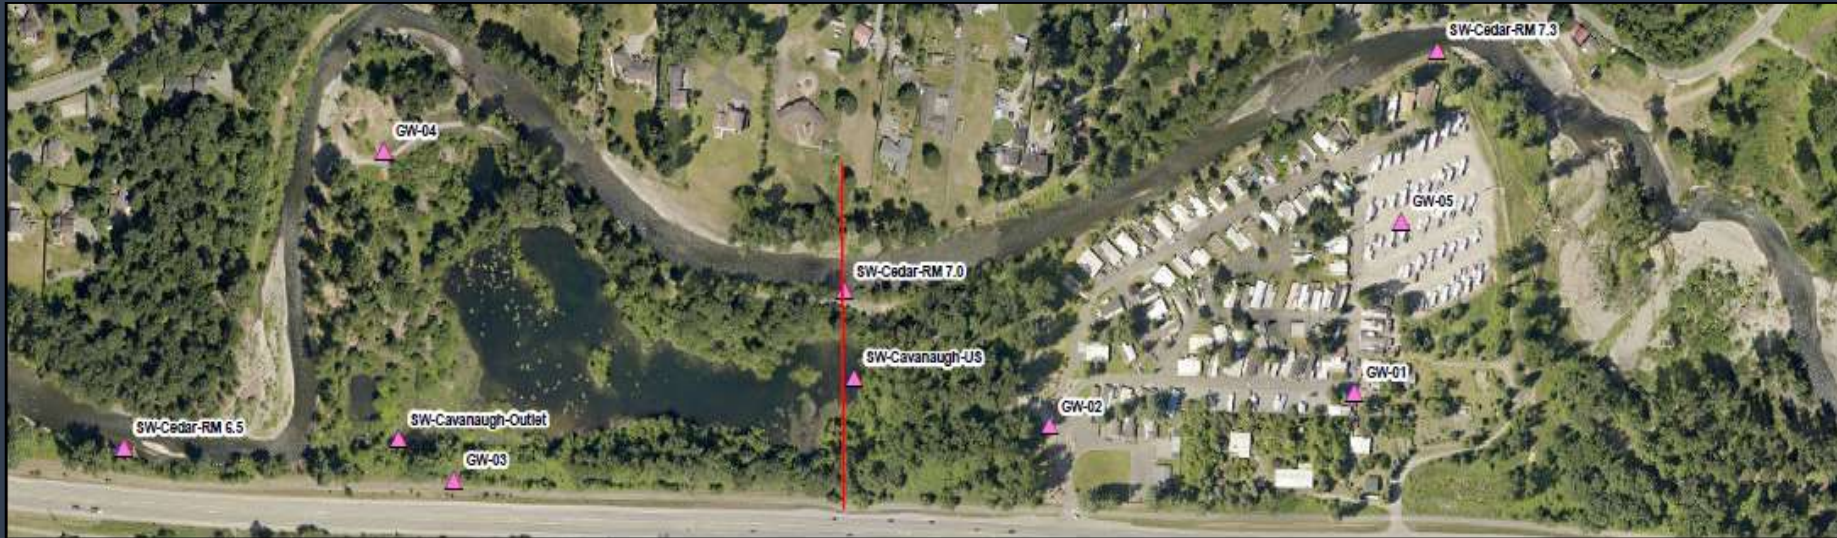
# Pond Modification

## Bathymetric Cross Section

Riverbend Levee Setback

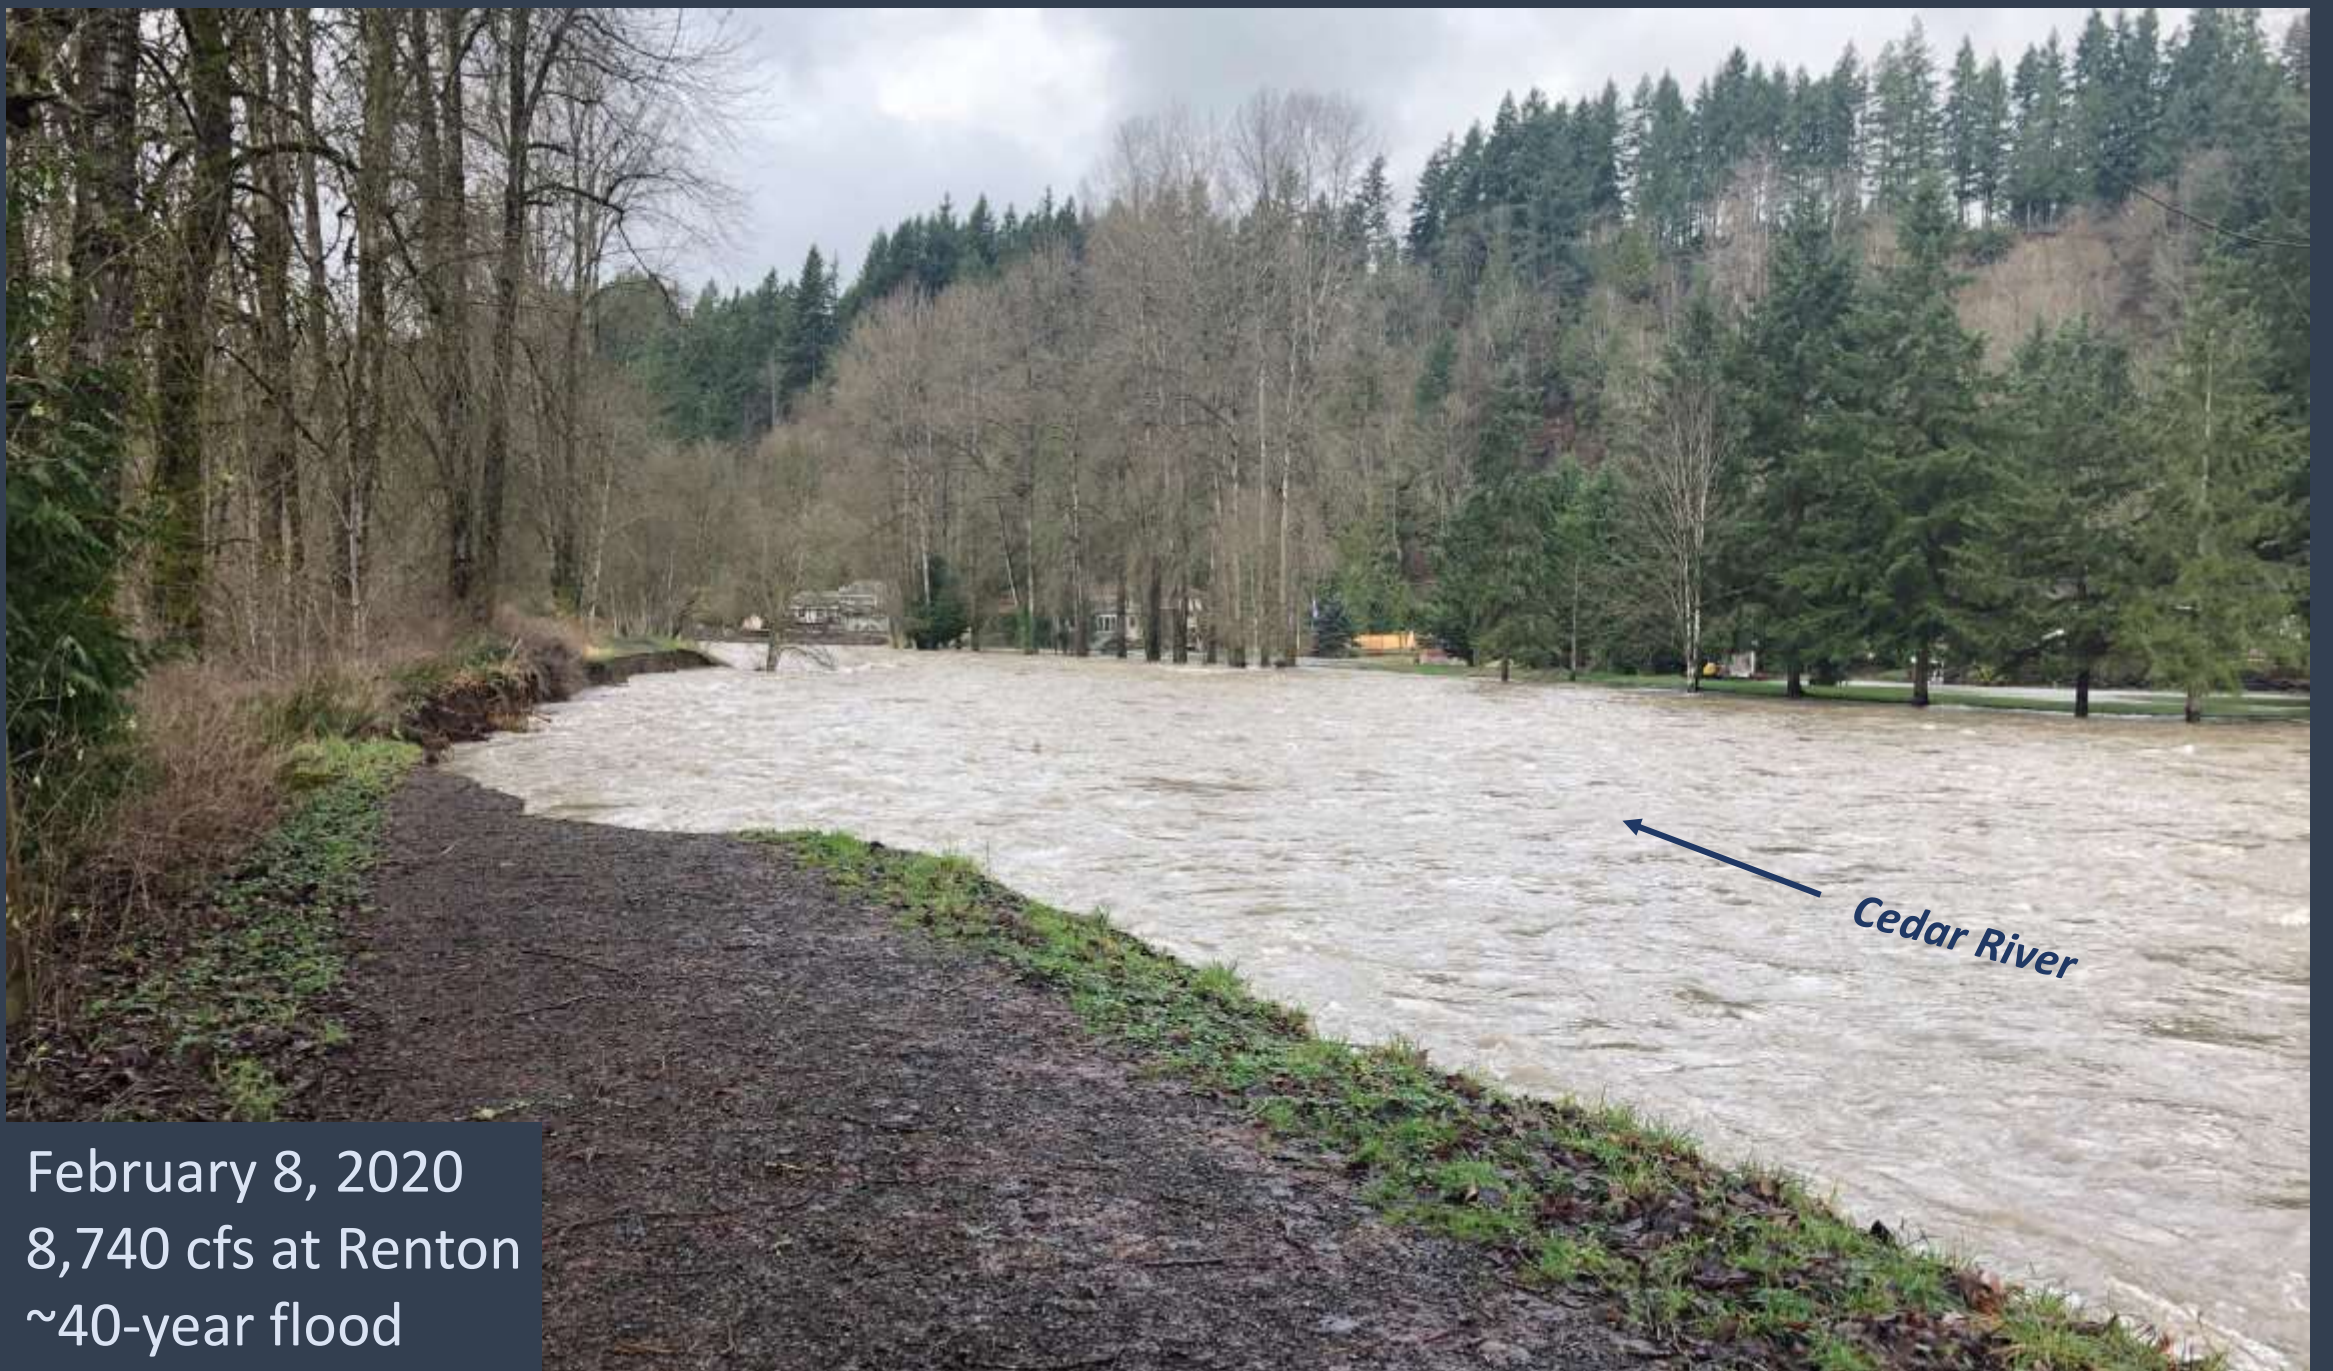
February 8, 2020  
8,740 cfs at Renton  
~40-year flood

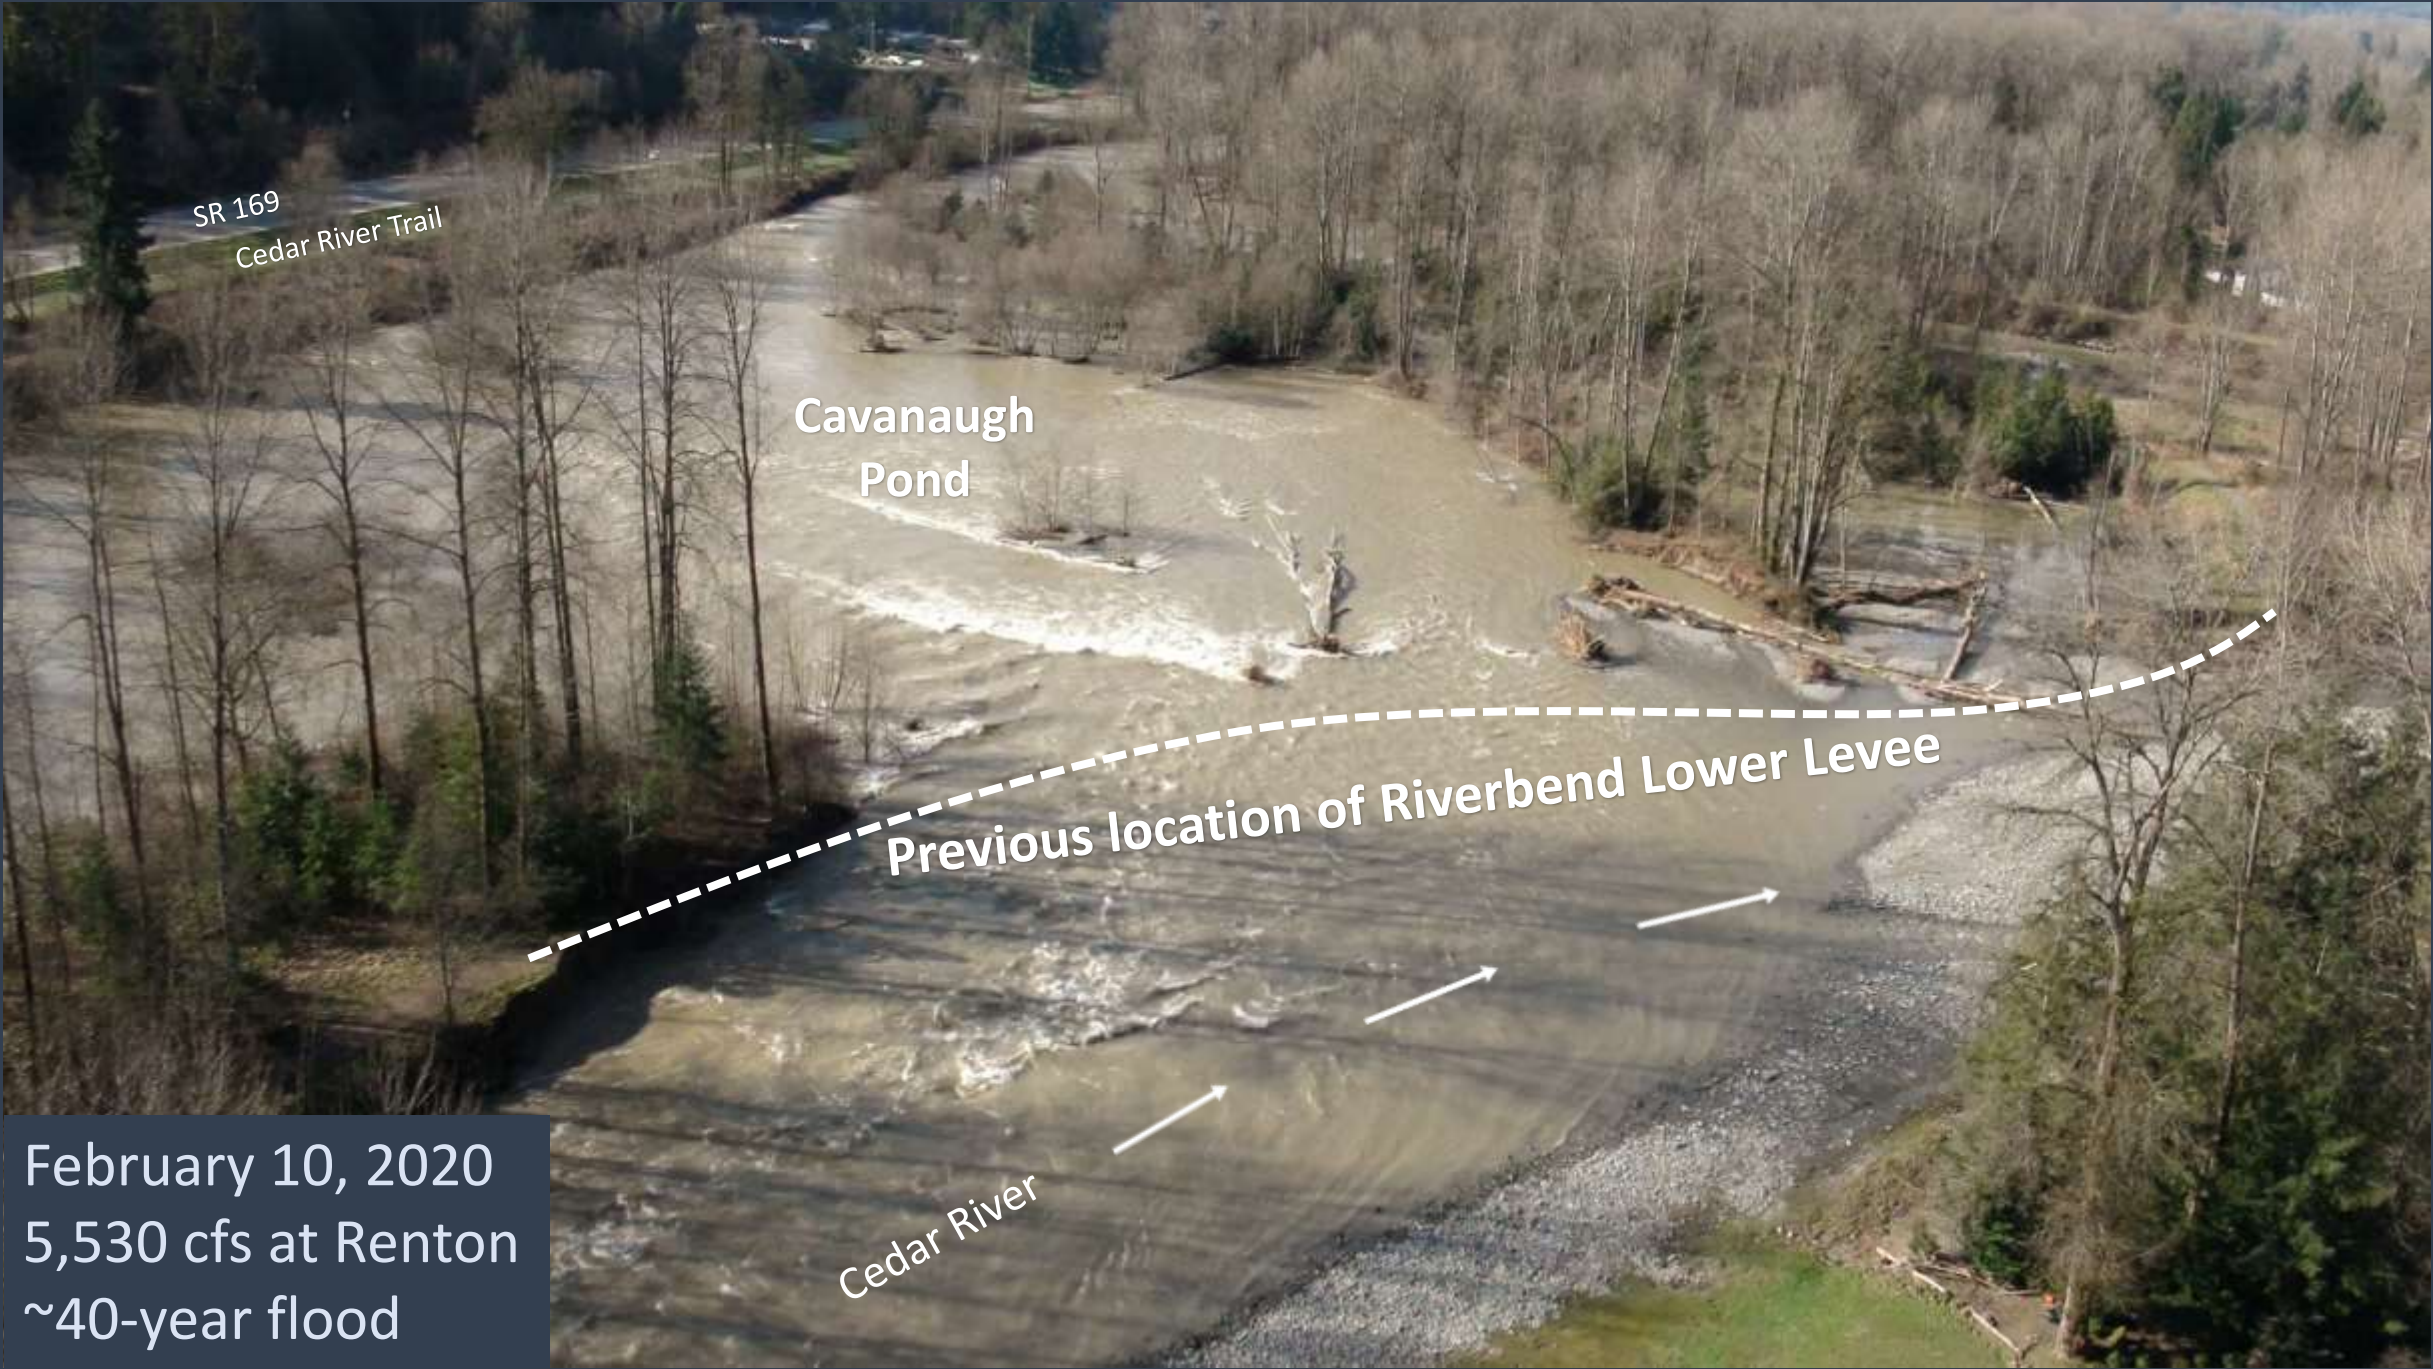
February 10, 2020  
5,530 cfs at Renton  
~40-year flood

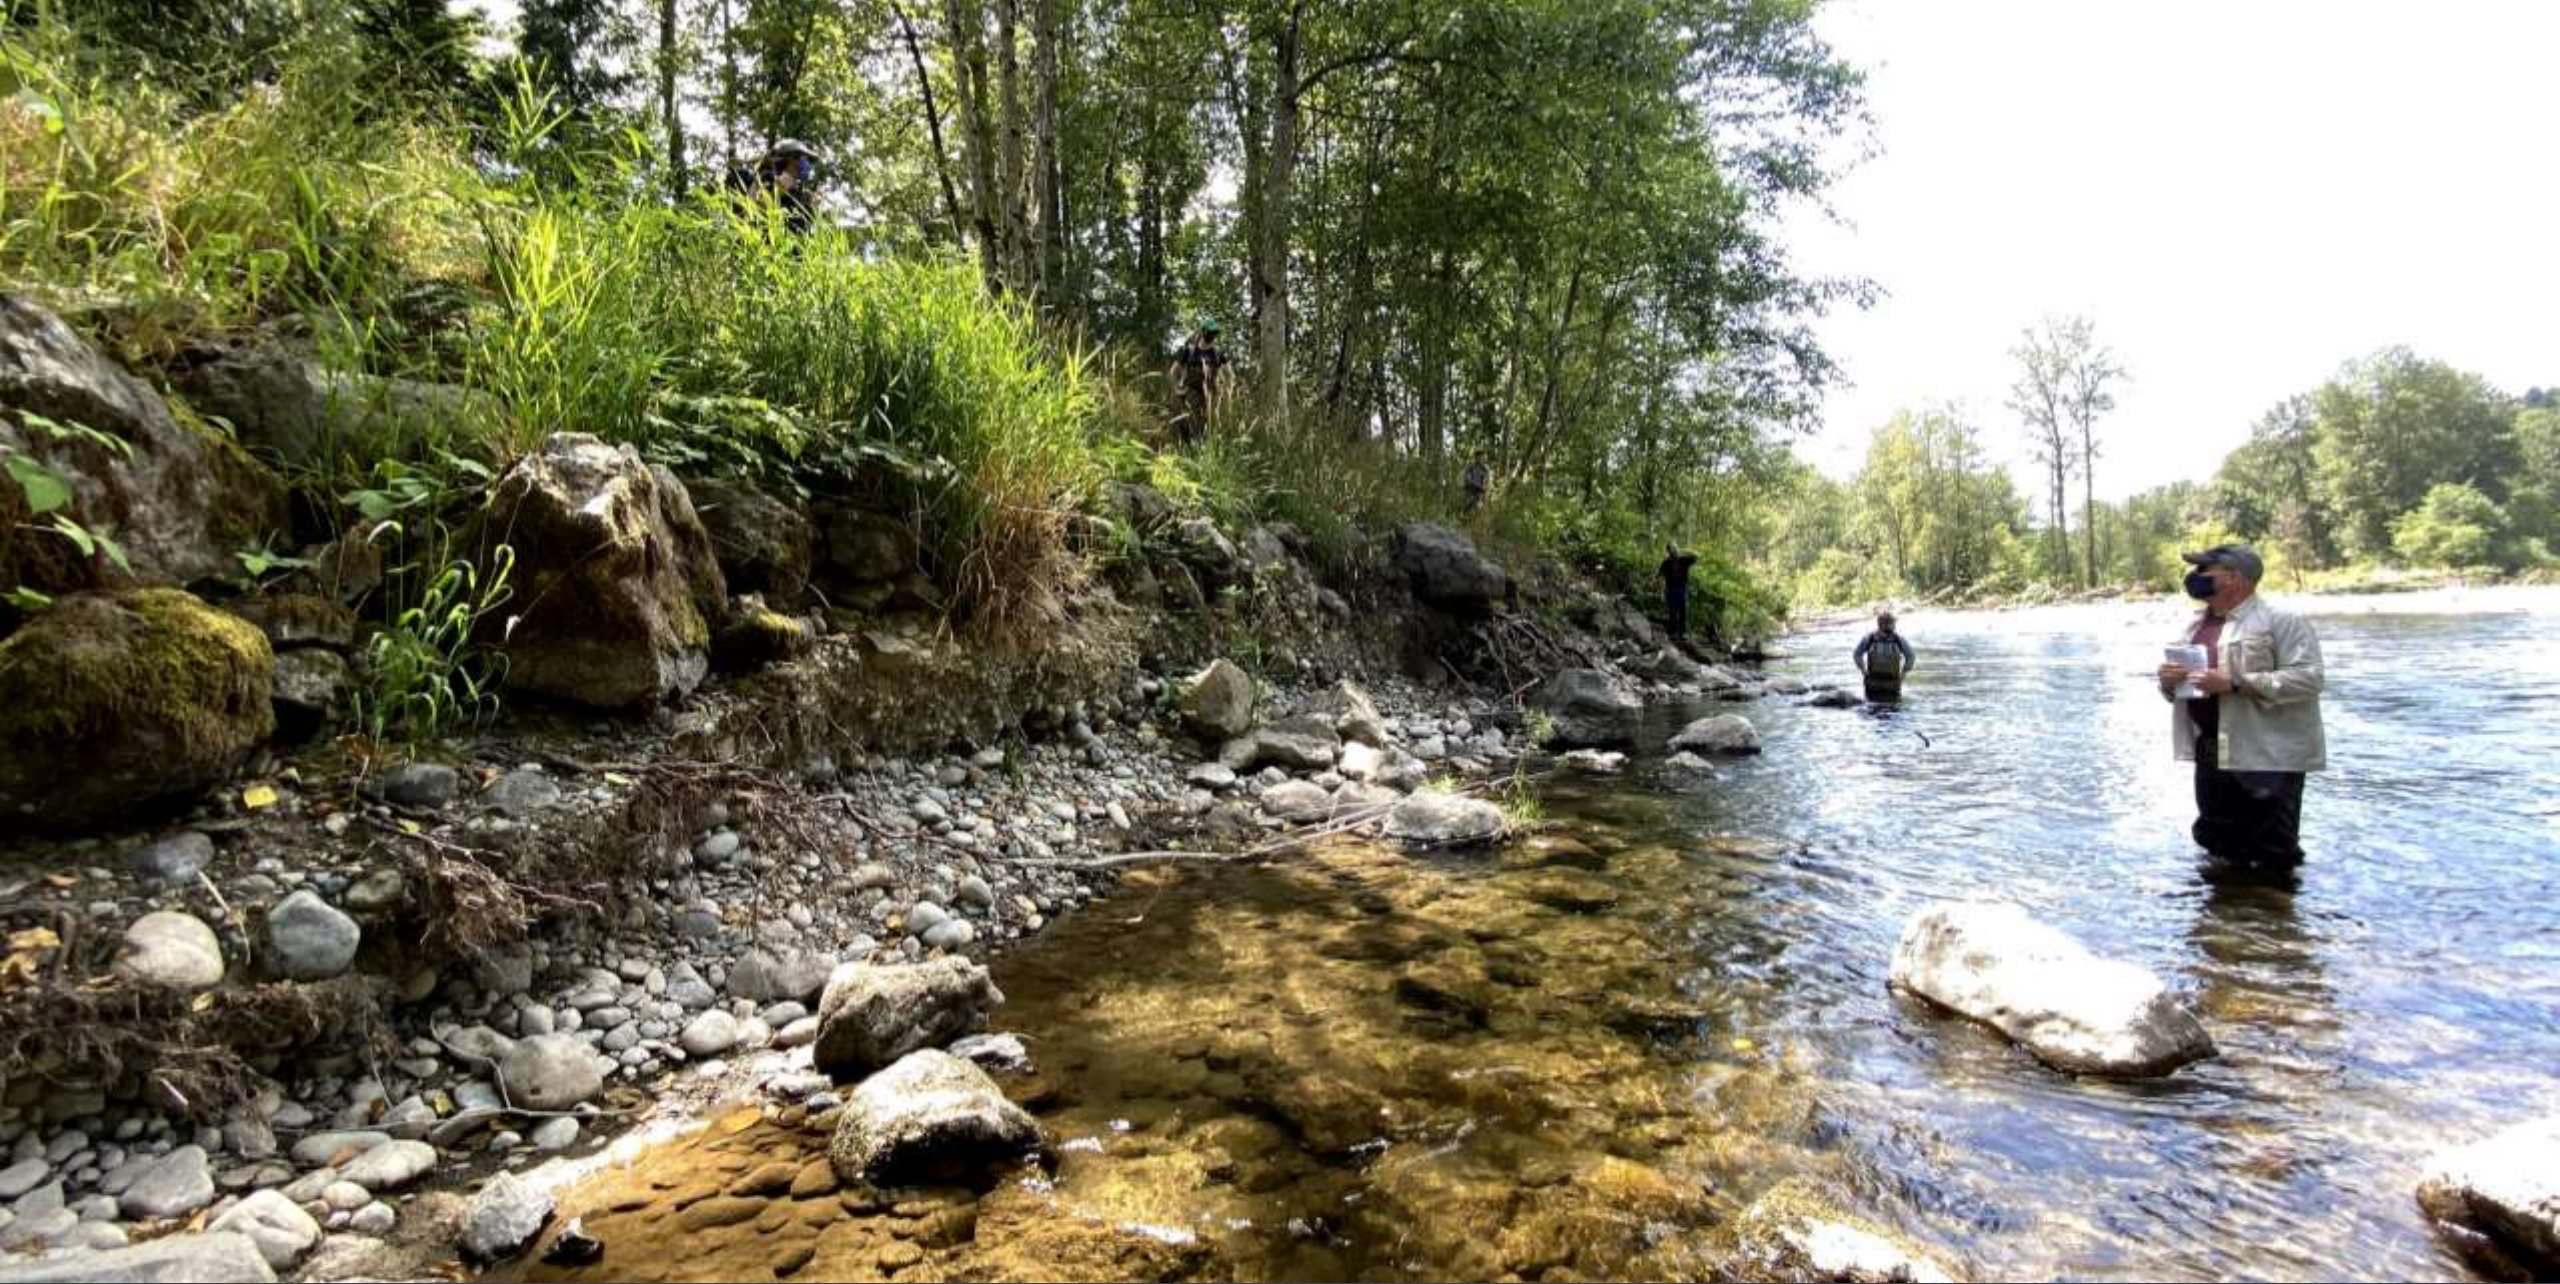
# Avulsion Reset Reach Conditions

- Complex habitat with off channel connection
- Significant gravel deposition AND head cutting
- Reset thalweg elevation of entire reach
- Undermined remaining levee
- Requires reassessment and redesign

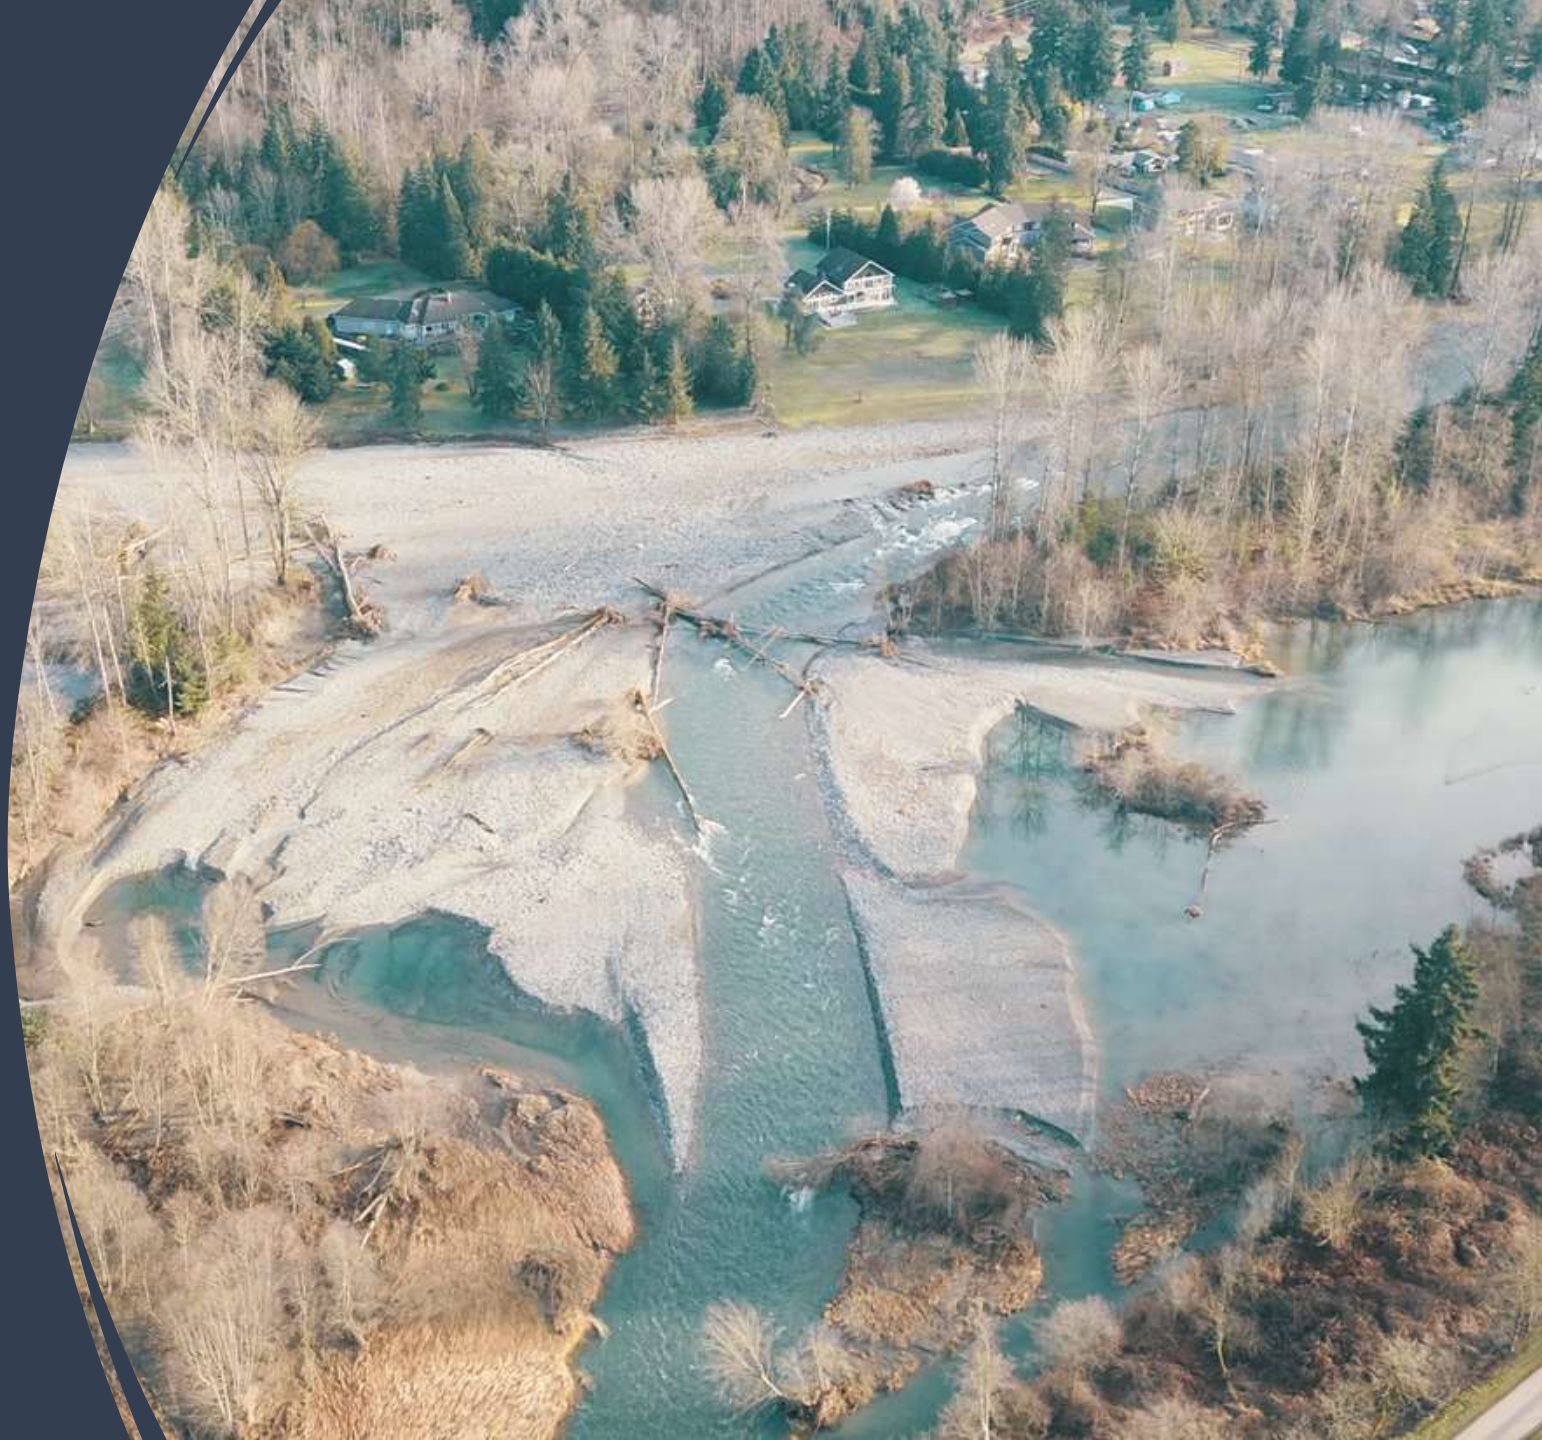
# Phase 1 – 2020

- Completion of Demolition
- Install buried setback through MH park
- Remove/Relocated Powerlines
- Extension of protection of Cedar River Trail

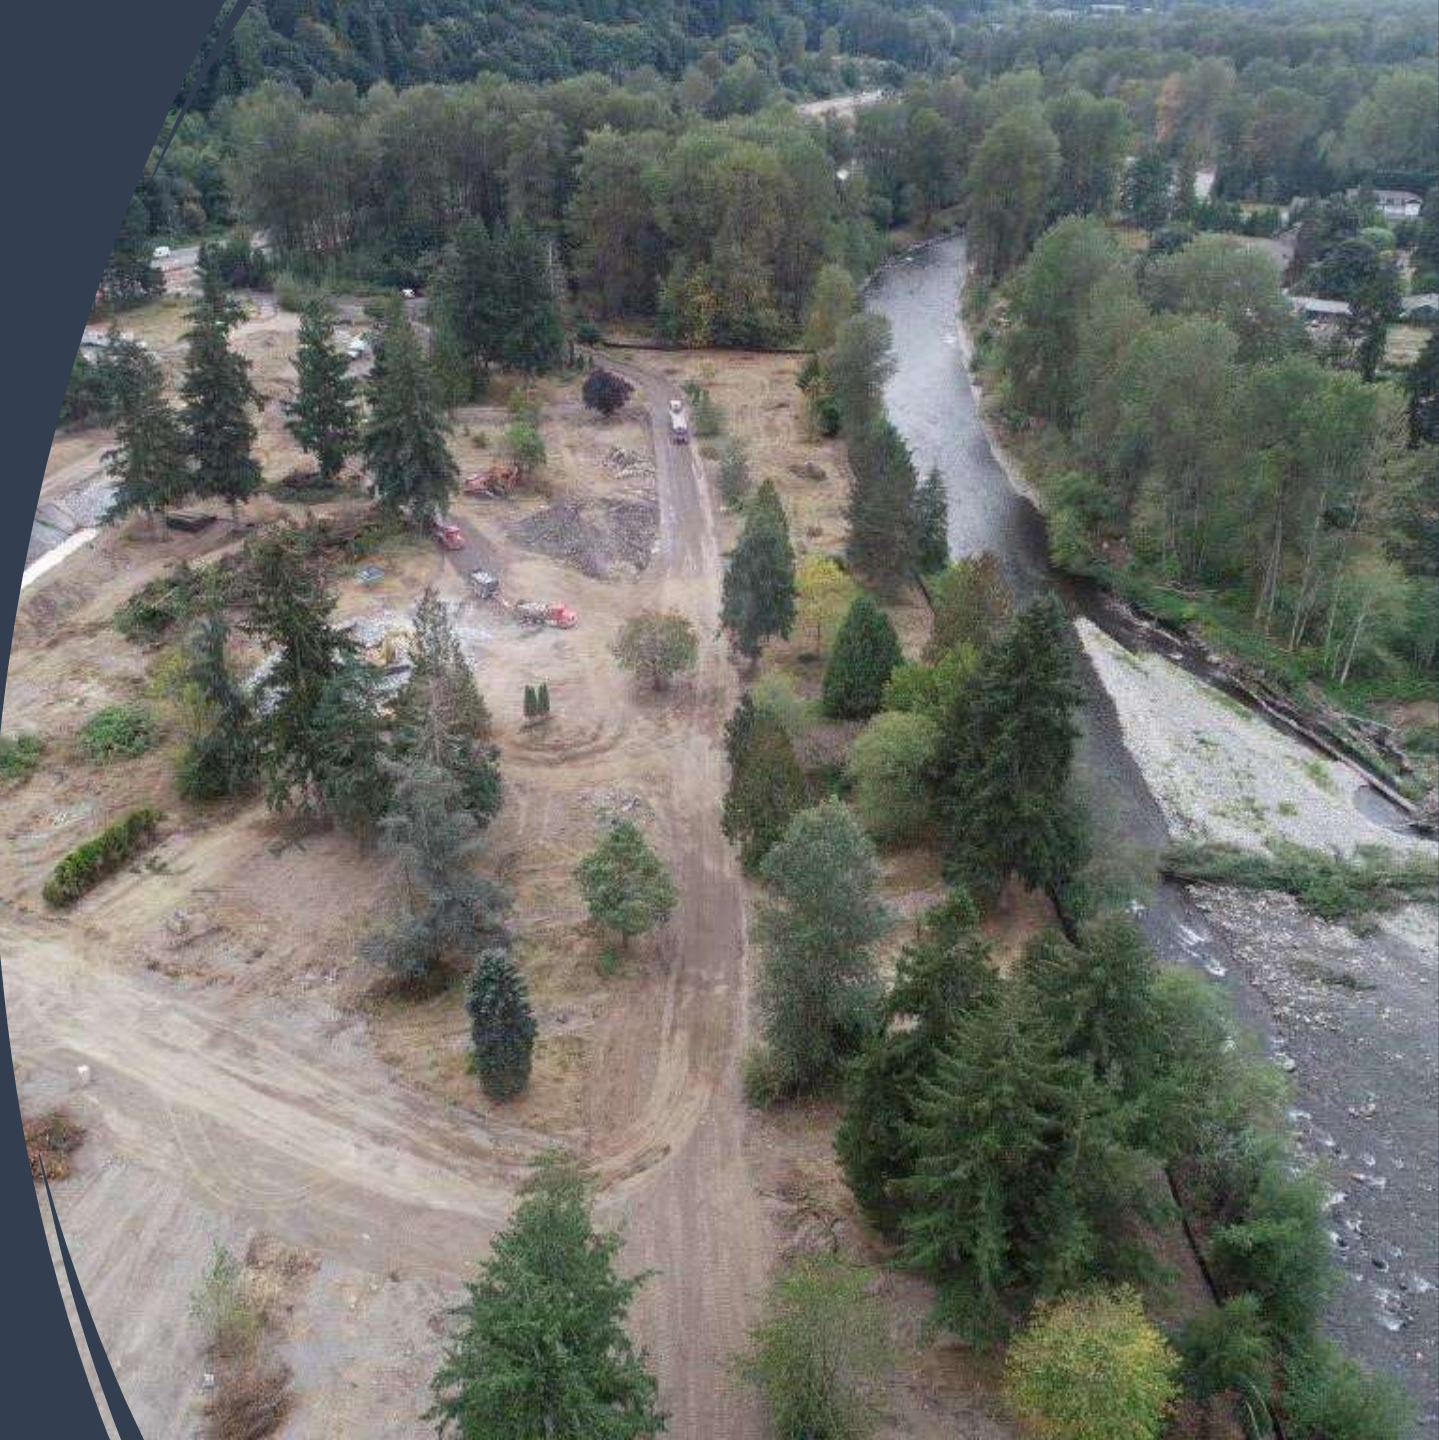
# Phase 1 – 2020

- Completion of Demolition
- Install buried setback through MH park
- Remove/Relocate Powerlines
- Extension of protection of Cedar River Trail
