# Riverbend

## Challenges and Opportunities of Restoring Habitat and Reducing Flood Risk in a Developed, Dynamic Environment

Presented by Michael Thai

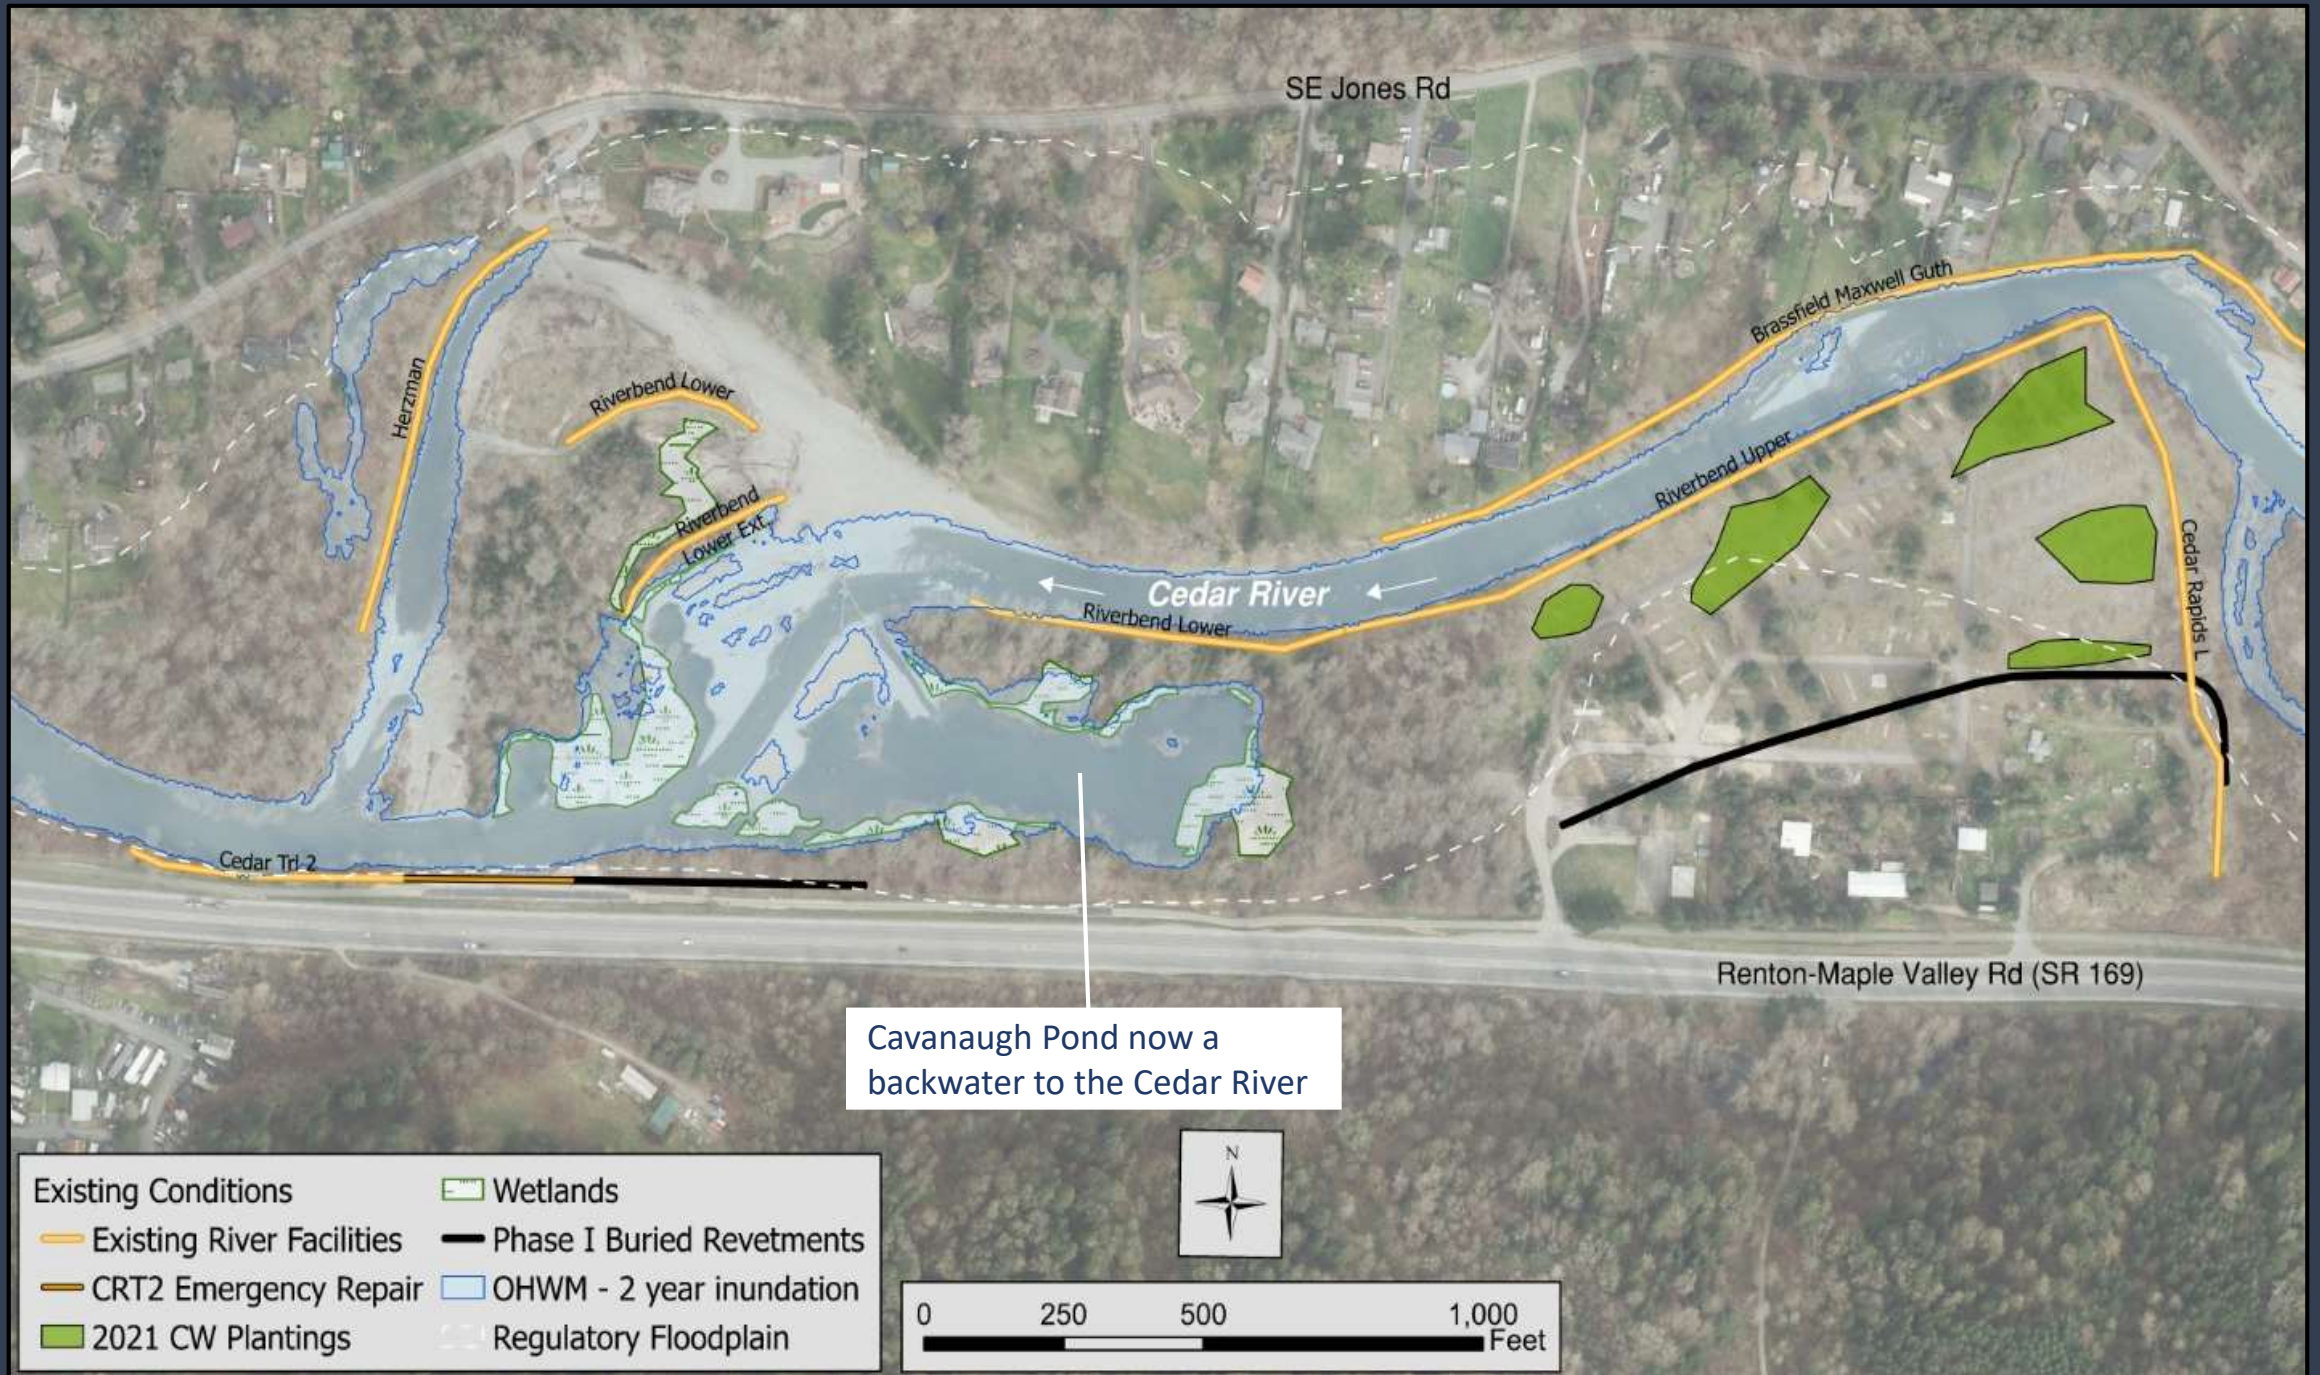
# Cottonwood Staking

- Winter 2021
- 3.5 acres
- 5,600 cottonwood stakes

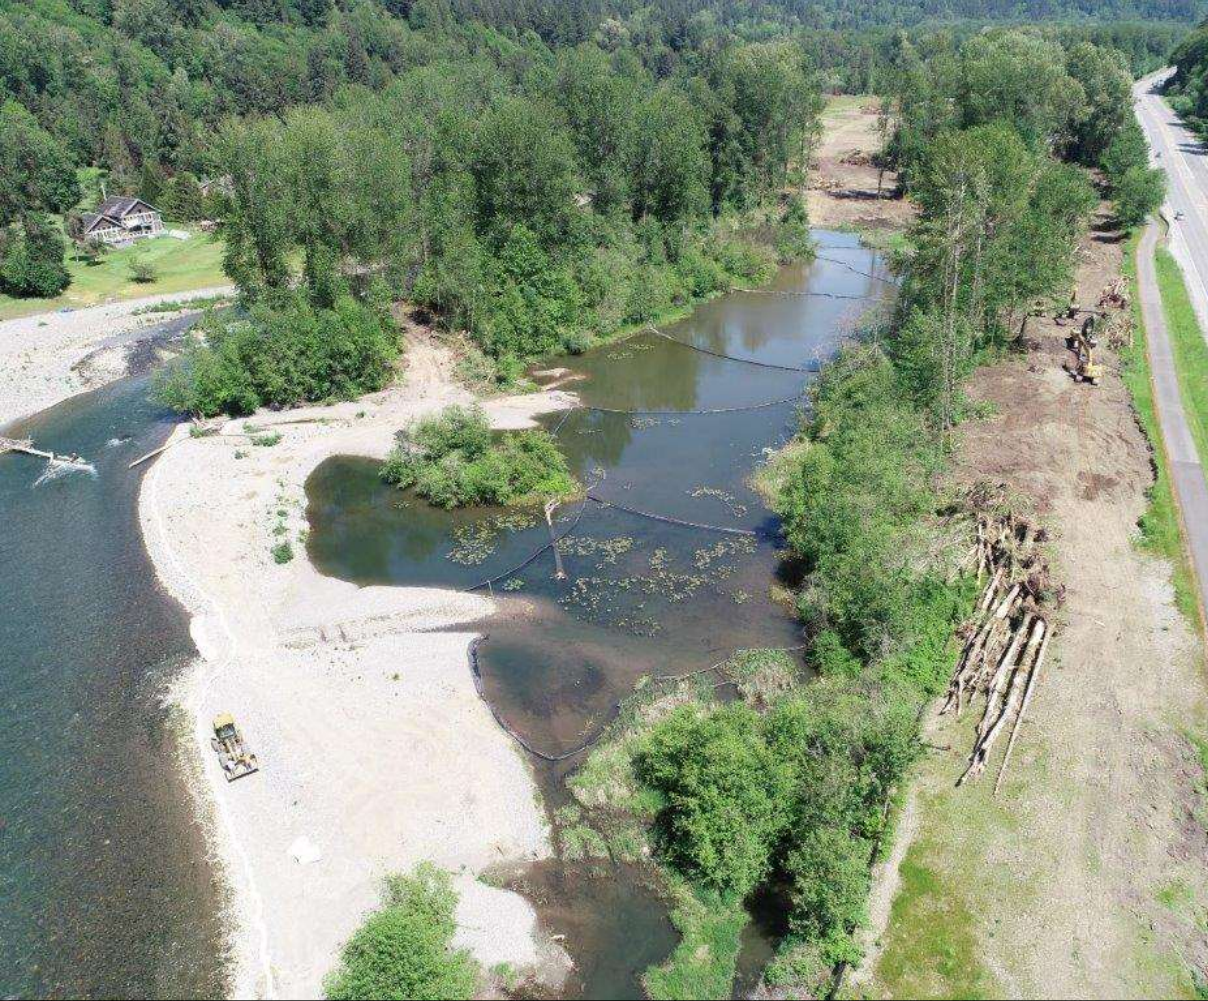
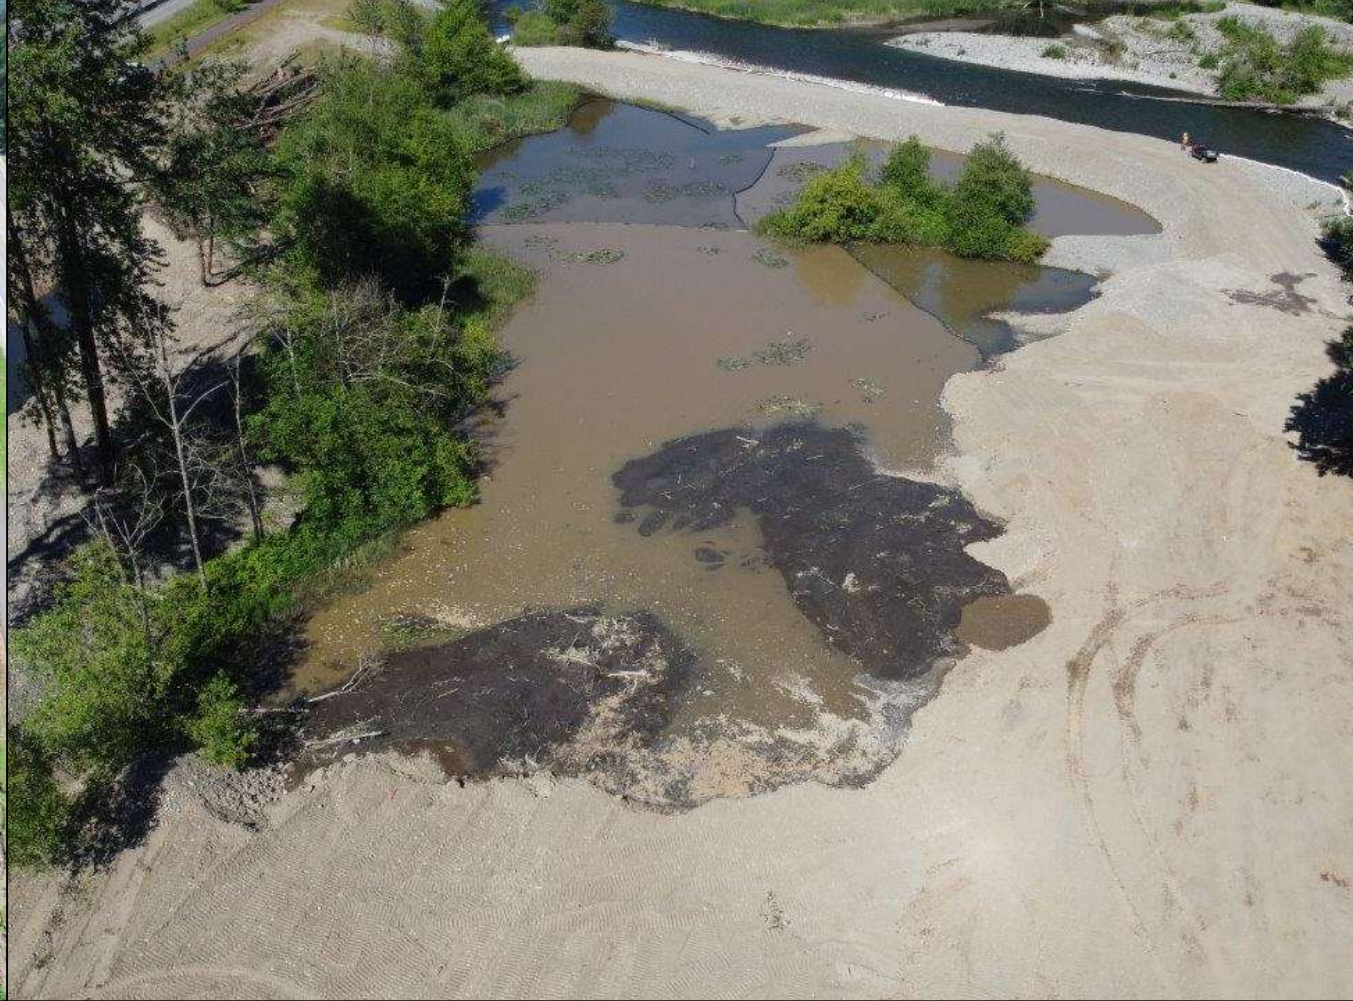
Isolate and Fill Cavanaugh Pond

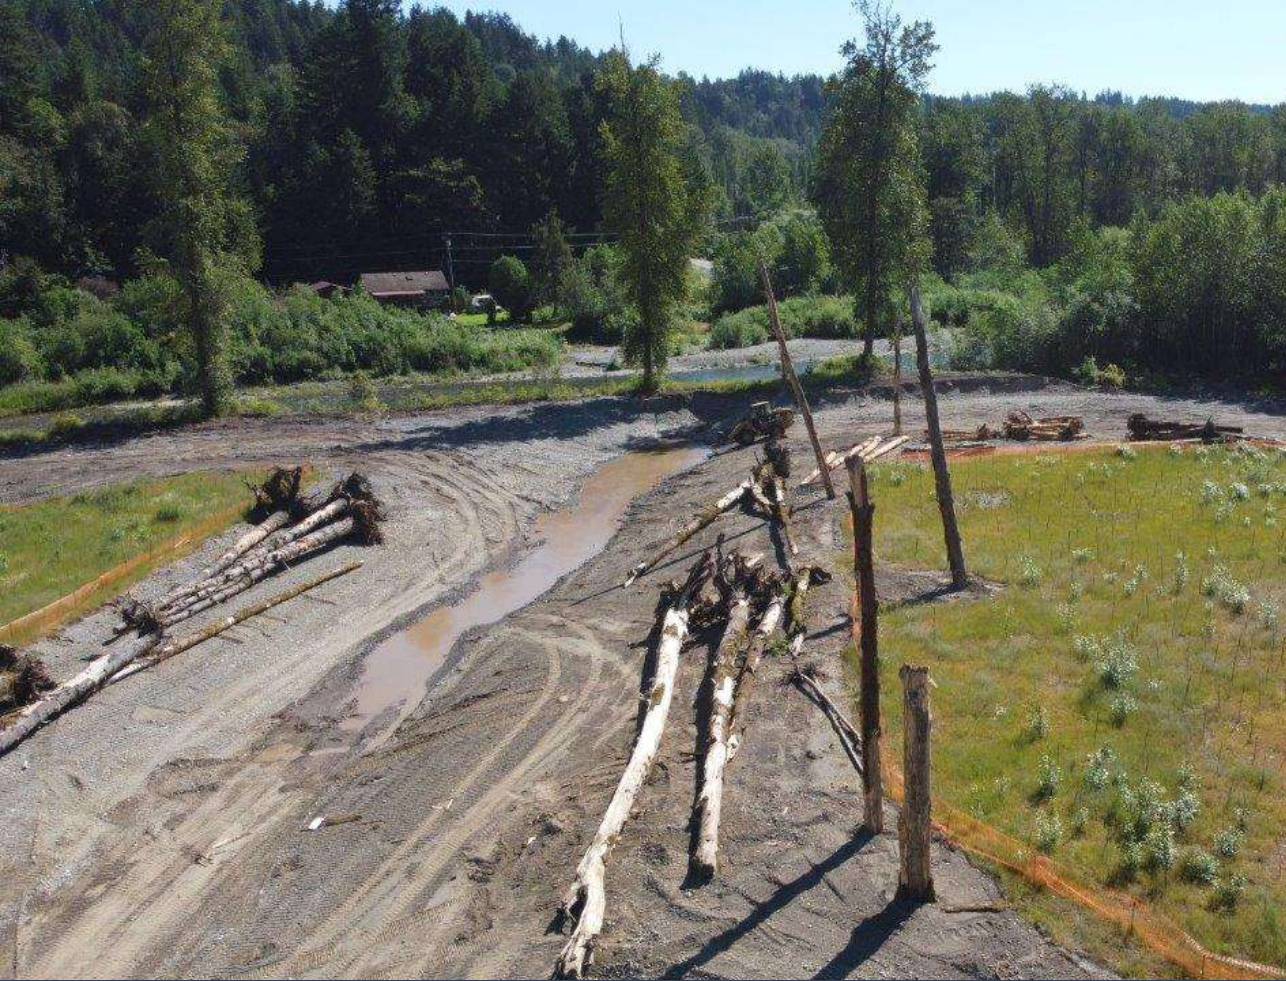
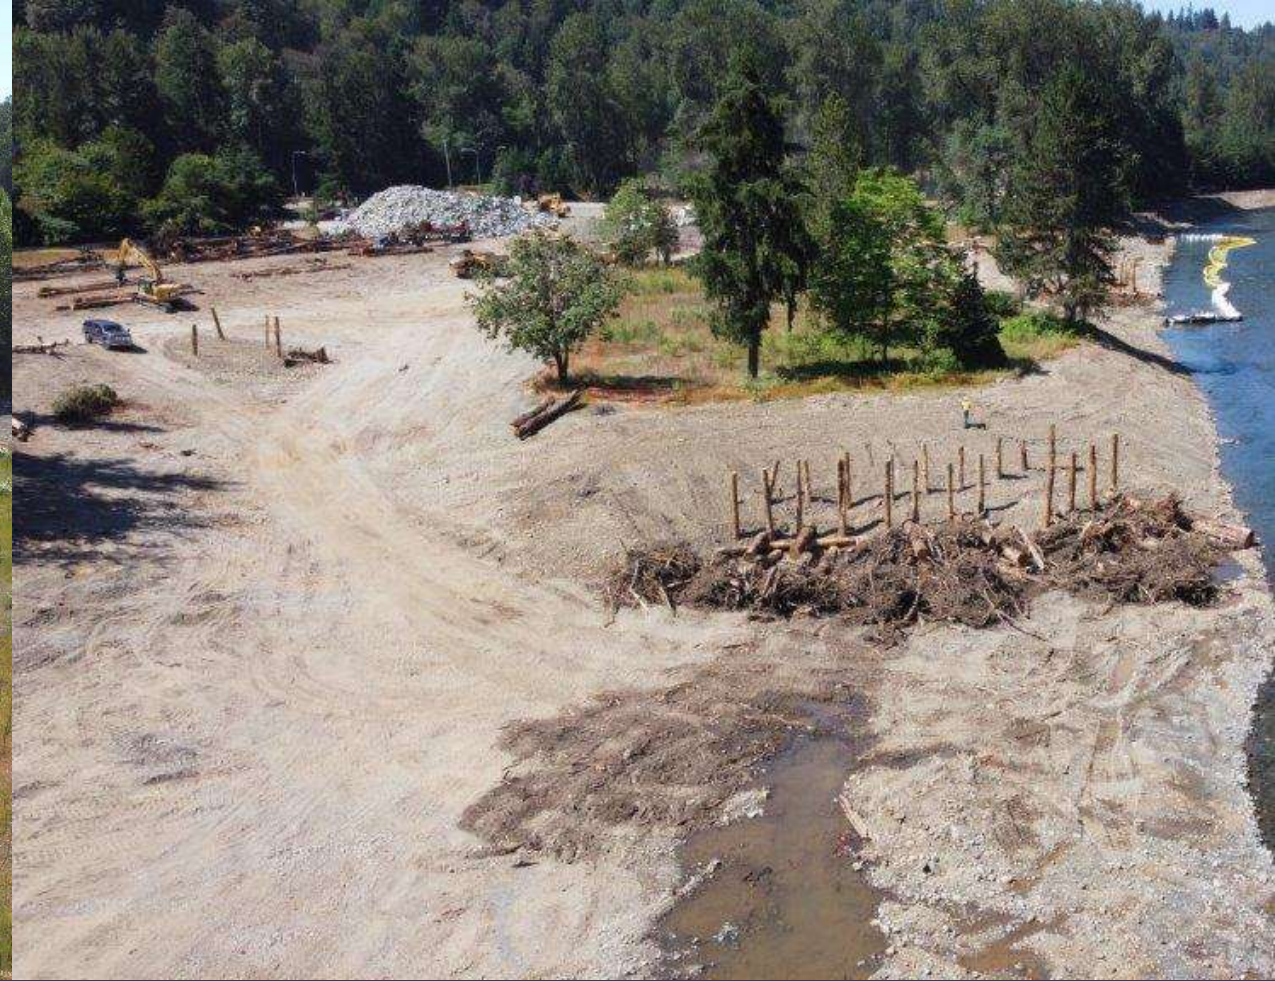
Excavate Side Channel in mobile home park area

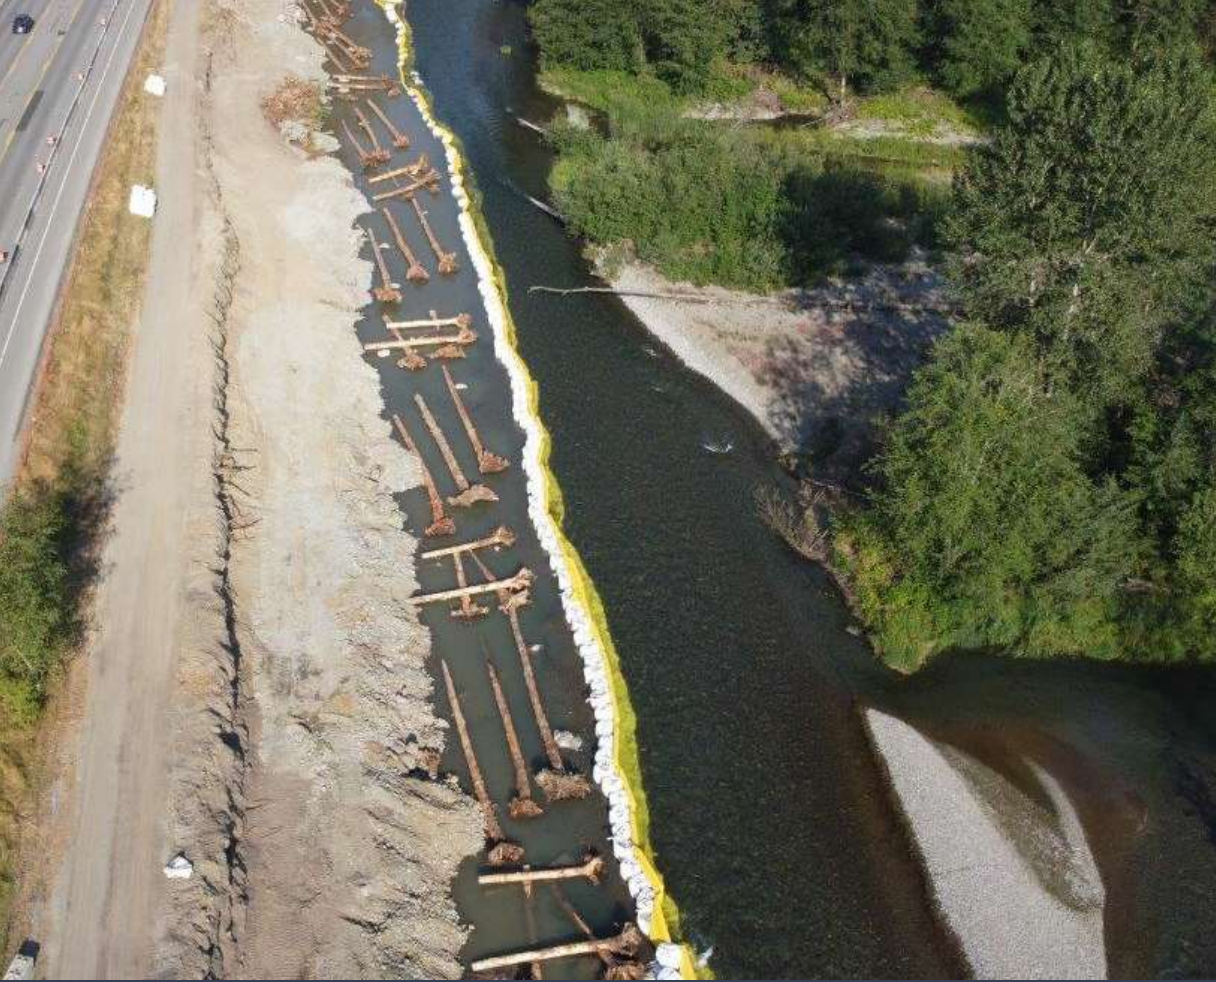
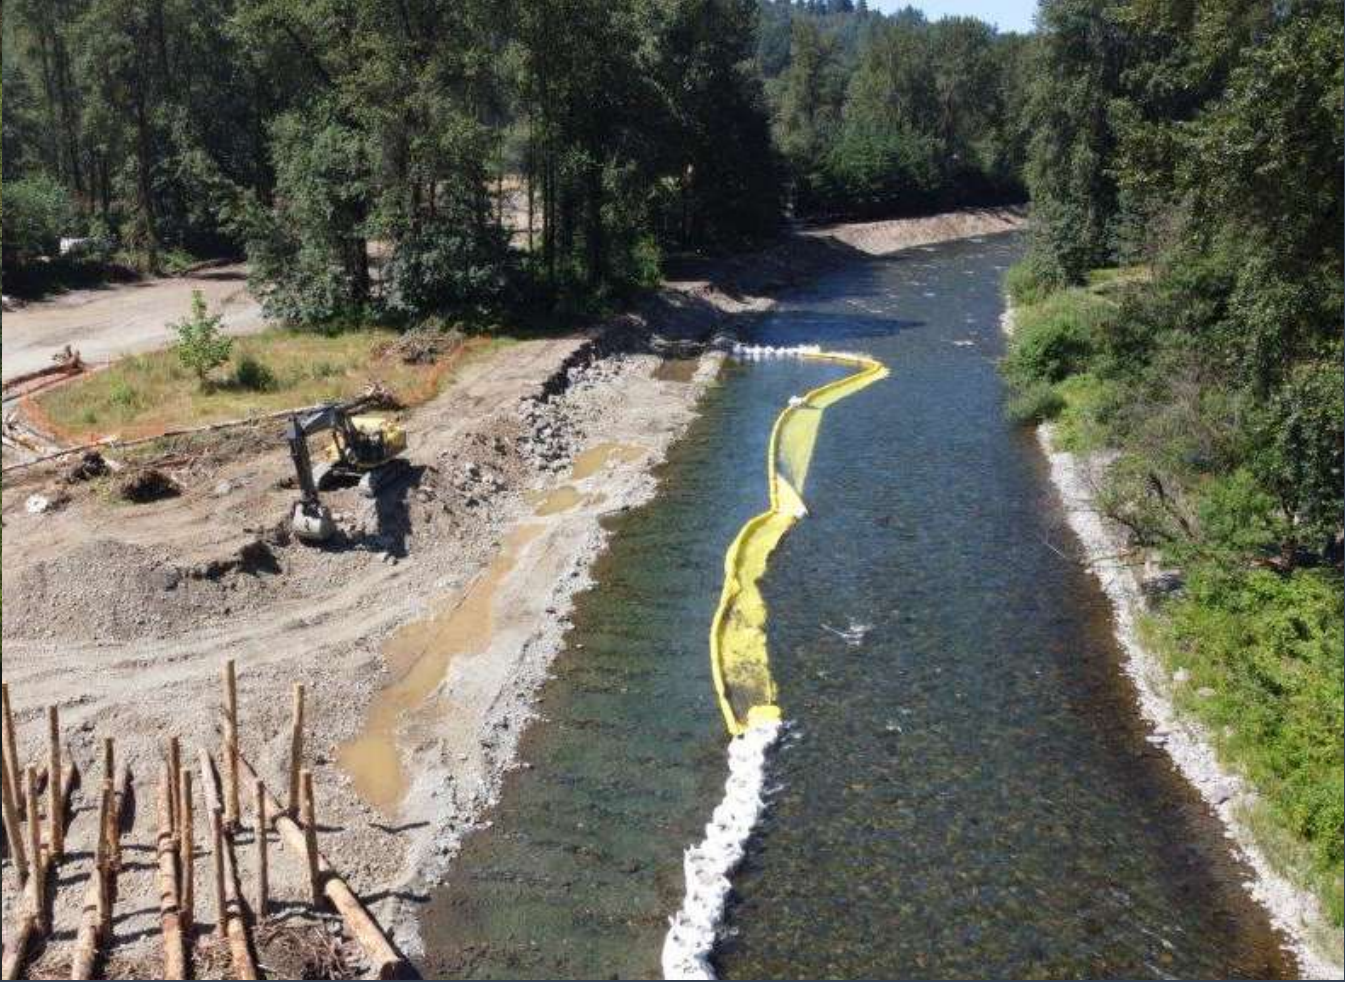
Isolate in-water work areas for riprap removal  
and log jam construction

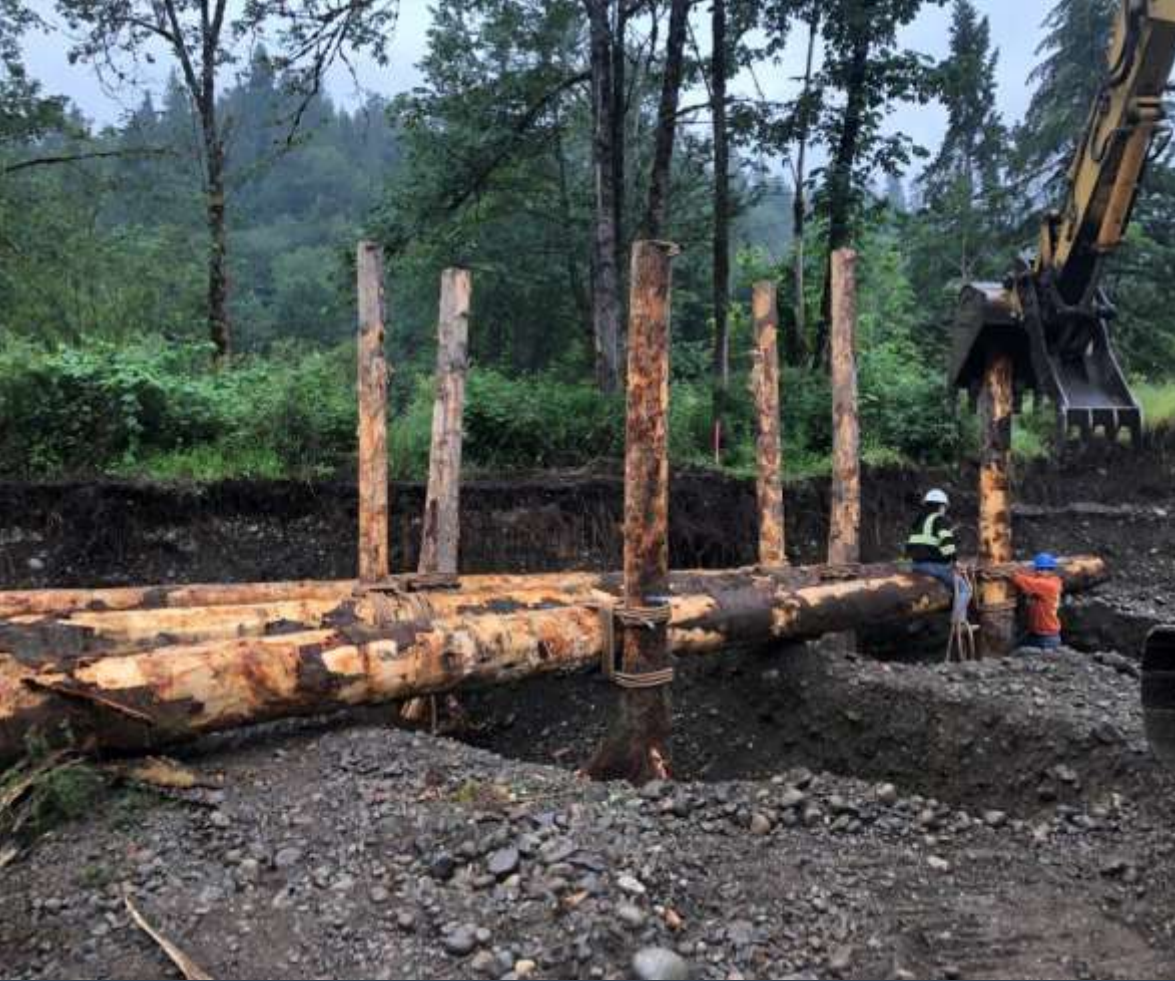
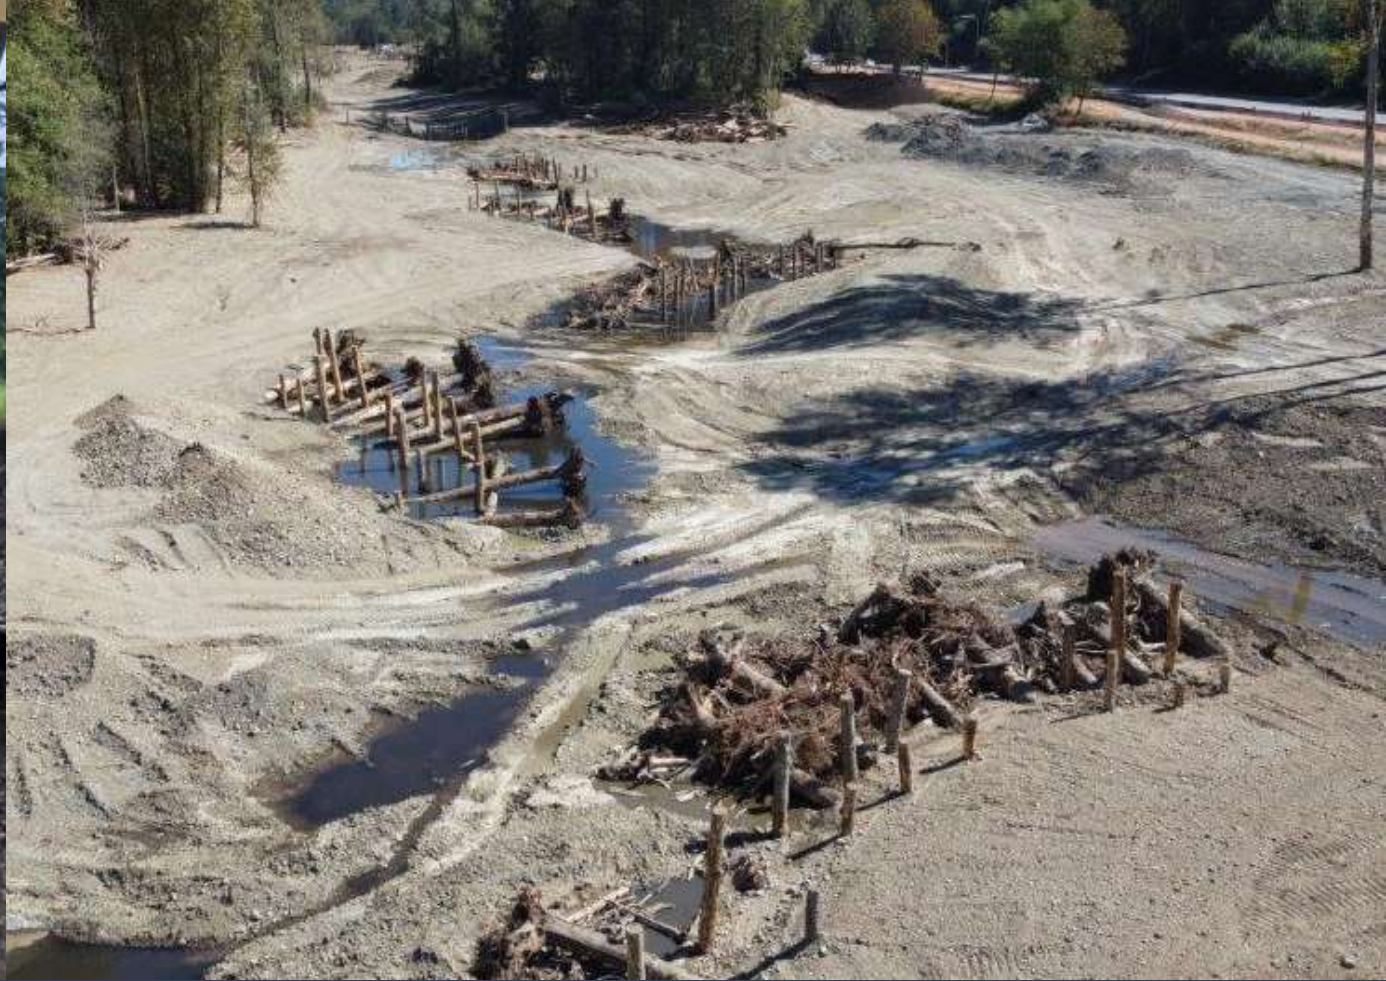
Build log jams in floodplain

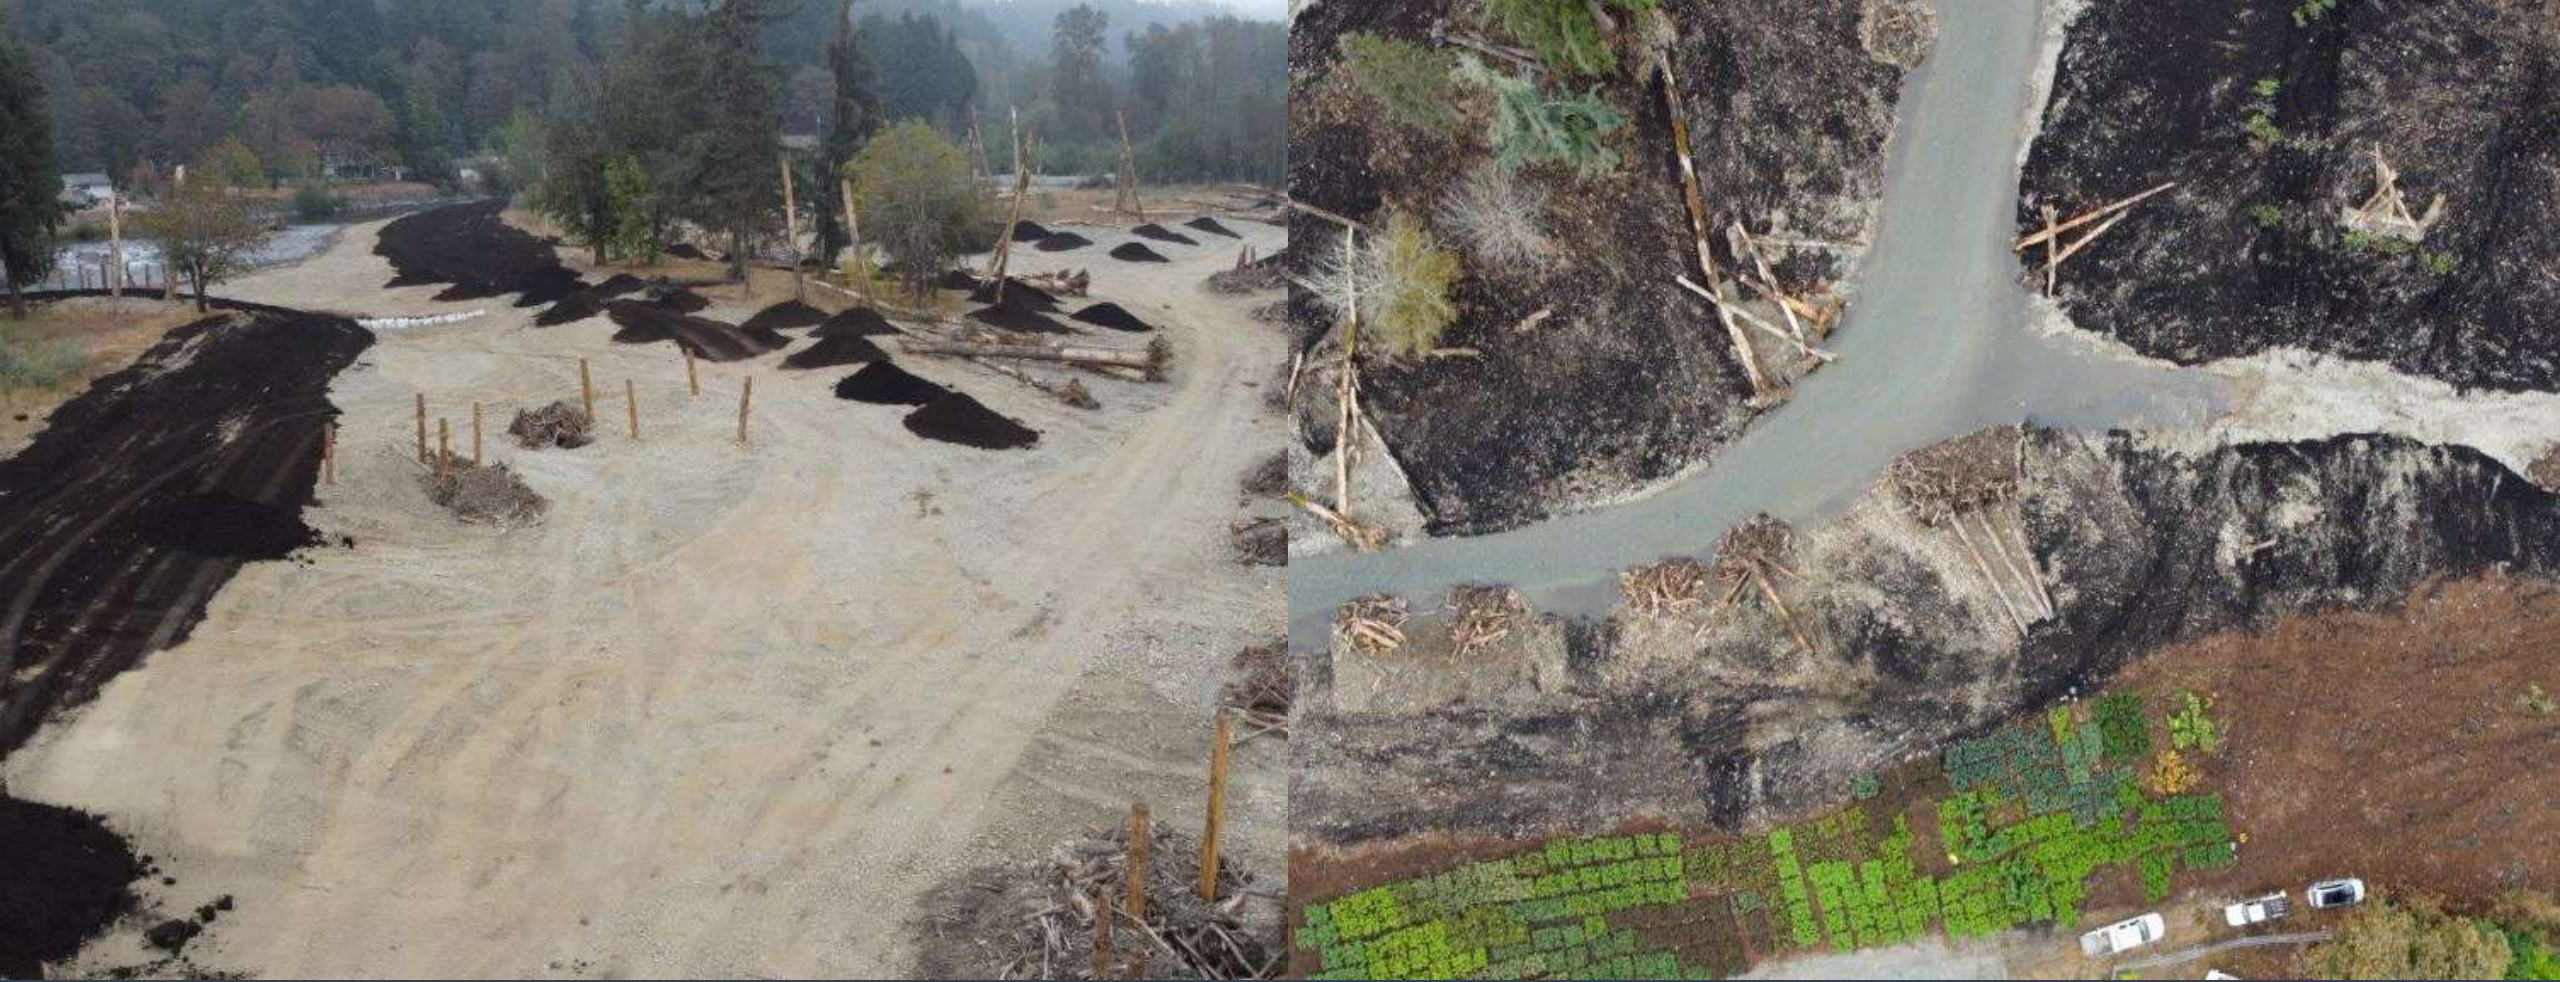
Spread compost and mulch (select areas), then plant

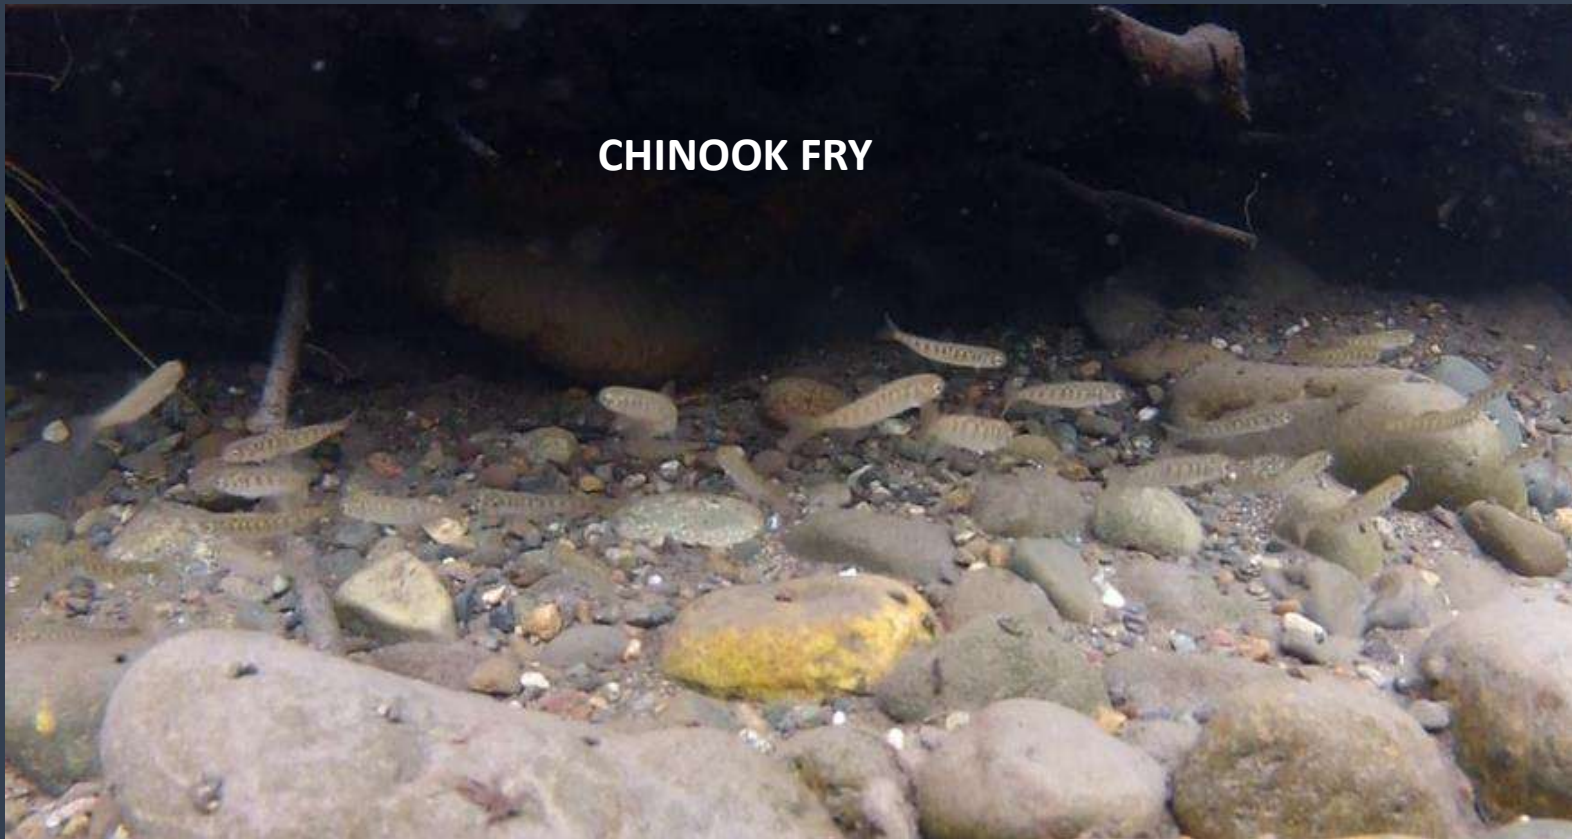
# 10-year Monitoring Plan

- Fish and habitat surveys
- Geomorphic change analysis using LiDAR
- Surface water level – floodplain connectivity
- Temperature analysis – possibly
- Vegetation establishment
- Weed management
